# A coastal landslide at West Down Beacon, Budleigh Salterton, Devon

P.G. KALAUGHER  
P. GRAINGER

*P.G. Kalaugher, Department of Engineering Science, University of Exeter, Devon.  
P. Grainger, Department of Geology, University of Exeter, Devon.*

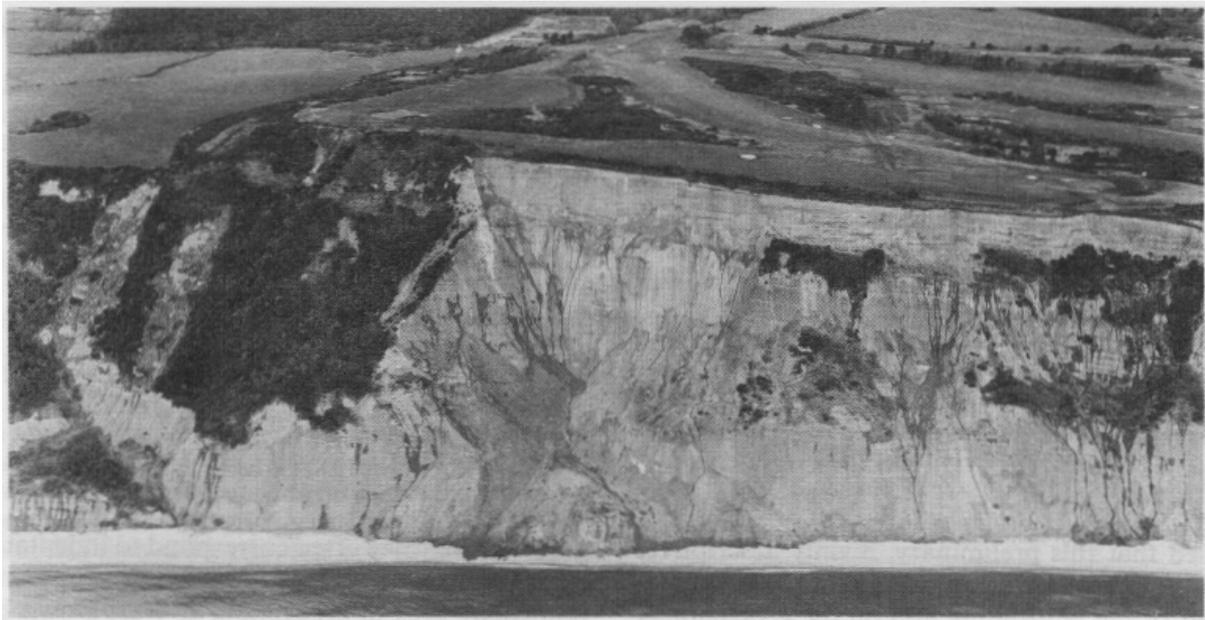
Examination of aerial photographs shows that there have been major changes in the morphology of the cliffs in the last few decades. The detailed morphology during 1980 (Fig. 1) is largely the result of movement of the main landslide following a major fall of conglomerate from the upper cliff in September 1979. The positions of geological features referred to in the text are shown in the accompanying drawing (Fig. 2). The line of the cross-section (Fig. 3) drawn through the main landslide is also indicated in Fig. 2. Topographic surveying is by terrestrial photogrammetry with a Wild P32 camera mounted on a TI theodolite but only approximate analytical methods have so far been used.

Figure 1. Oblique aerial view of West Down Beacon with the main landslide area in the middle of the picture. Photograph by J. Saunders on 22nd March 1980.

It is probable that some points of discharge of groundwater from the mudstone, similar to those visible in Fig. 1, become blocked by the debris. Wherever the debris is relatively impermeable and a higher point for the discharge has to be found, the groundwater pressure is increased. This means that, before a fall from the conglomerate, the effective stresses in the potential slip zone between the mudslide and the in situ mudstone may already be somewhat lower than expected.

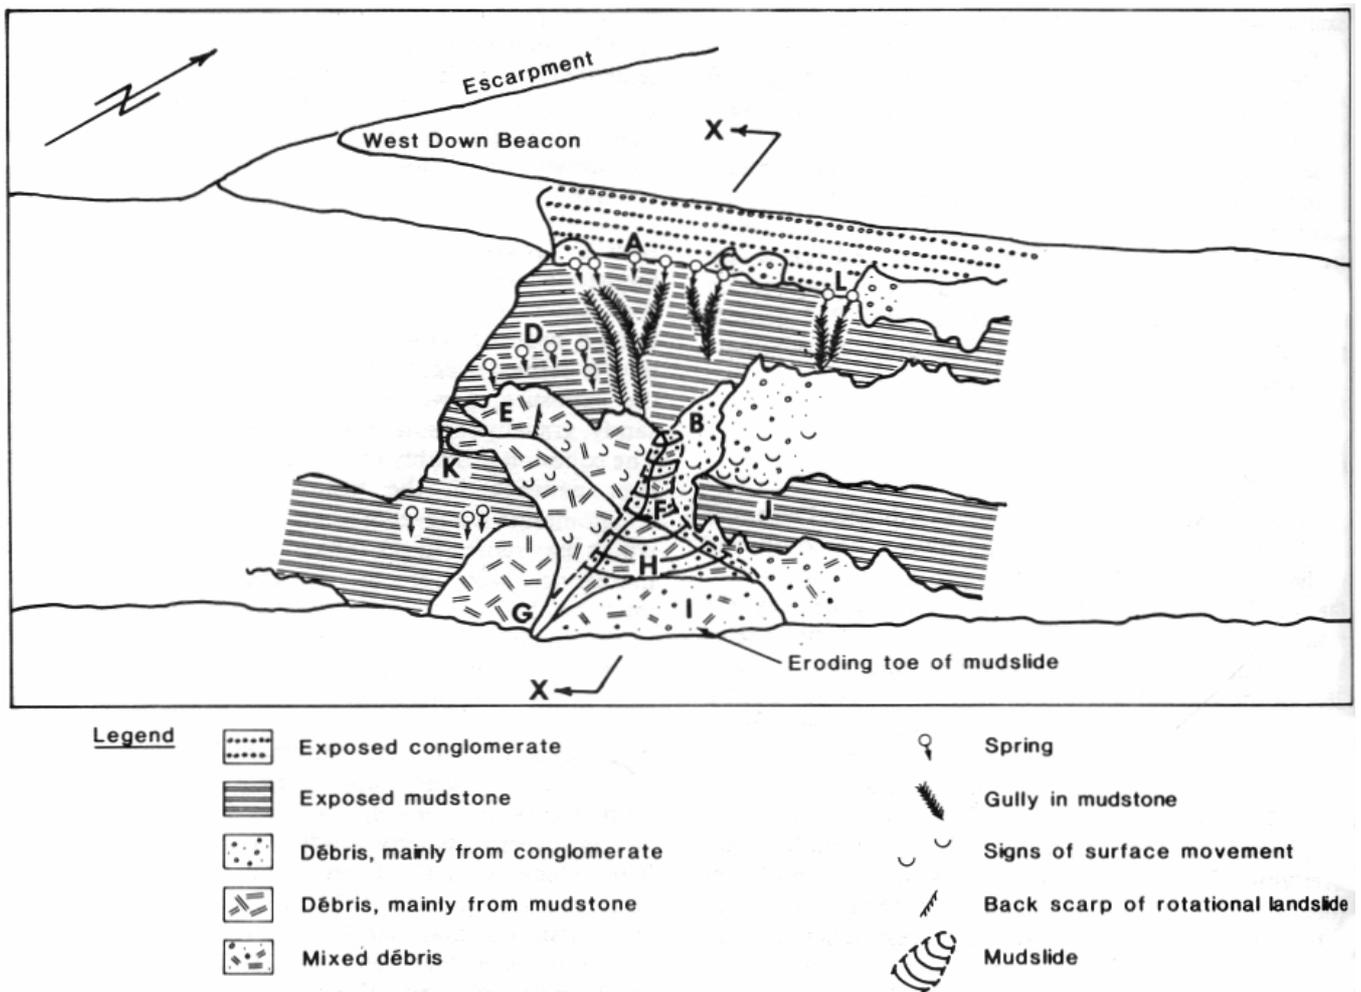
Figure 2. Interpretation of the landslide area of Figure 1. X-X indicates the line of the cross-section, Figure 3. The other letters mark areas referred to in the text.

The groundwater emerging (e.g. at A in Fig. 2) causes seepage erosion at the base of the very weakly cemented conglomerate and assists in its oversteepening. This leads to sudden falls of the cliff above. The larger falls, occurring every few years, cause cliff-top recession of the order of 2 to 3 metres and involve near-vertical slices of conglomerate. The shape of the upper cliff suggests that poorly developed joints partly control the geometry of the slices. There is a range in scale from these infrequent large falls down to the falling of individual pebbles, which becomes a continuous process during the winter months. Typically the debris from the large falls rapidly reaches B (Figs. 2 and 3) but that from the small scale falls can form screens on the ledge on top of the mudstone and be banked up against the lower part of the conglomerate as at C.

The emergent groundwater runs over the mudstone in the cliff face, softening the surface and forming gullies. The thin resistant beds of grey siltstone and silty sandstone to some extent impede this gully development. As can be seen at D (Fig. 2) water also emerges from the mudstone at particular levels, some of which correspond to the grey layers. The gully erosion and surface softening lead locally to instability of the fissured and jointed mudstone and there are frequent falls of blocks up to 0.5m in size. These blocks disintegrate and soften rapidly on exposure.

On the western side at E where there is only a little conglomerate debris, the softened mudstone has been affected by rotational slips and the resulting backtilting has interrupted the surface drainage. The slips direct some material into the main slide area between B and F while other material is contributed to the flow of debris towards G (Fig. 2).

On both sides of the main landslide area, at J and K (Fig. 2), a hard band in the mudstone forms a capping to the lowermost part of the cliffs. The drainage from the base of the conglomerate at L was diverted from the main landslide area towards J by the debris from the fall in September 1979. This drainage adds water to the conglomerate debris on the shallow slope immediately above the hard band. Sand, gravel and cobbles in a mudstone slurry flow over the hard band and onto the beach.

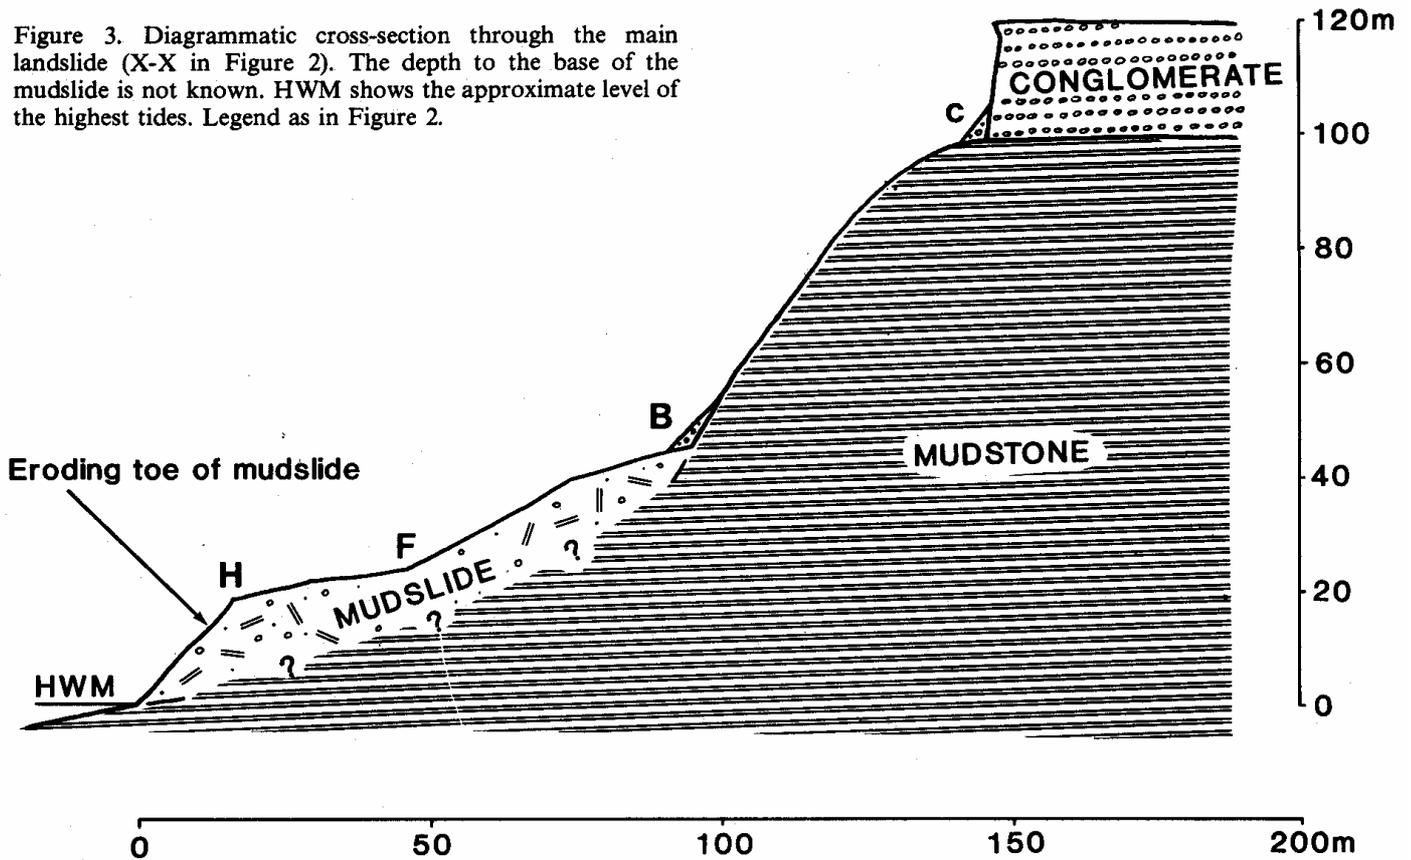
Figure 3. Diagrammatic cross-section through the main landslide (X-X in Figure 2). The depth to the base of the mudslide is not known. HWM shows the approximate level of the highest tides. Legend as in Figure 2.
