RENEWED LANDSLIDE ACTIVITY AT PINHAY, LYME REGIS

P. GRAINGER AND P. G. KALAUGHER

Grainger, P. and Kalaugher, P.G. 1995. Renewed landslide activity at Pinhay, Lyme Regis. *Proceedings of the Ussher Society*, **8**, 421-425.

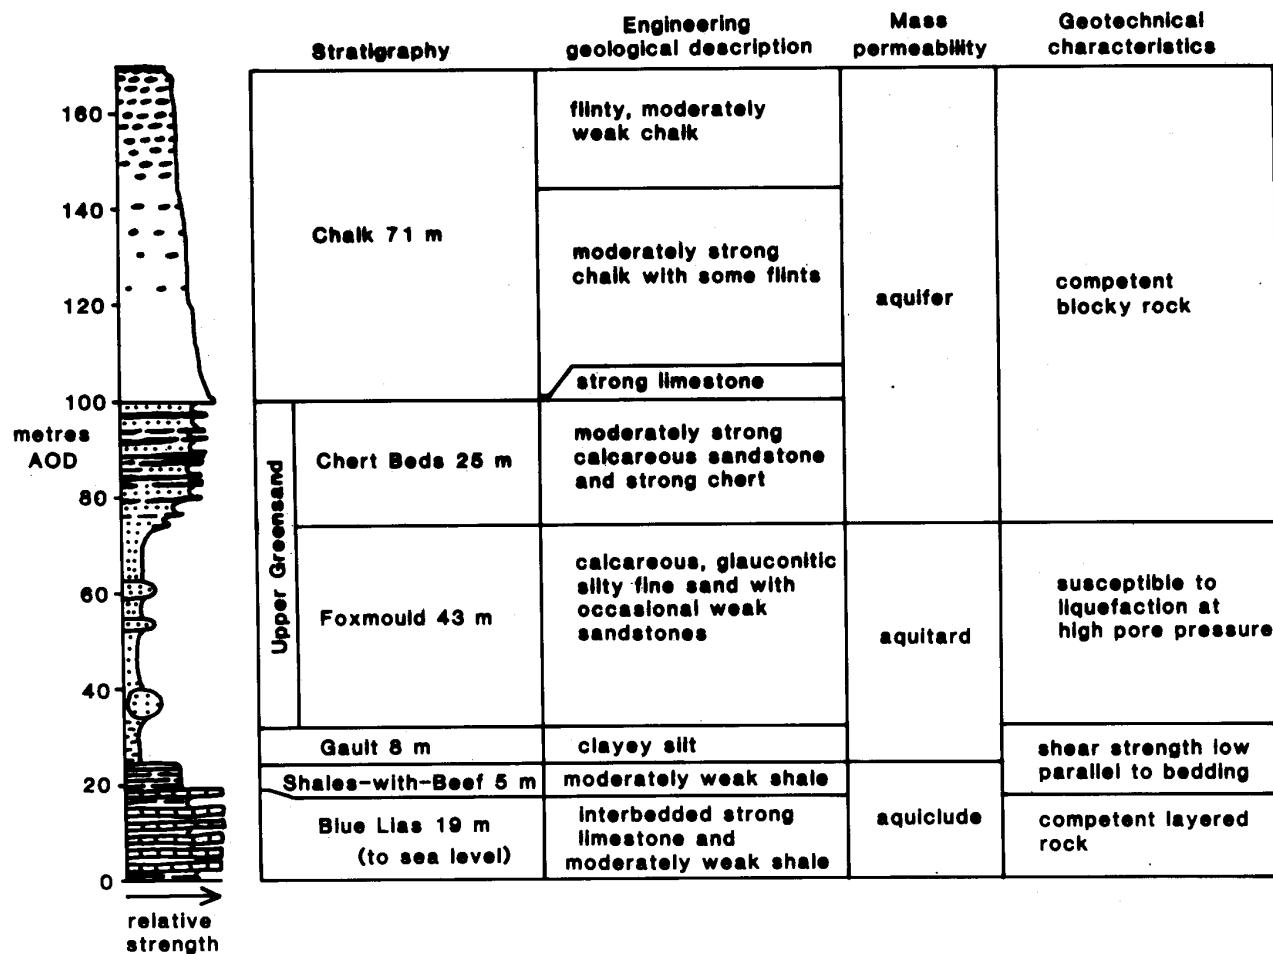
All of the strata in this area, where undisturbed by landsliding, are very gently dipping or virtually horizontal. The succession and significant geotechnical features of the formations, from sea level to the top of the cliff, are shown in Figure 2, which represents an interpretation of published geological information, taken from Grainger *et al.* (1985).

Figure 2. Stratigraphic column, with important properties (after Grainger et al., 1985).

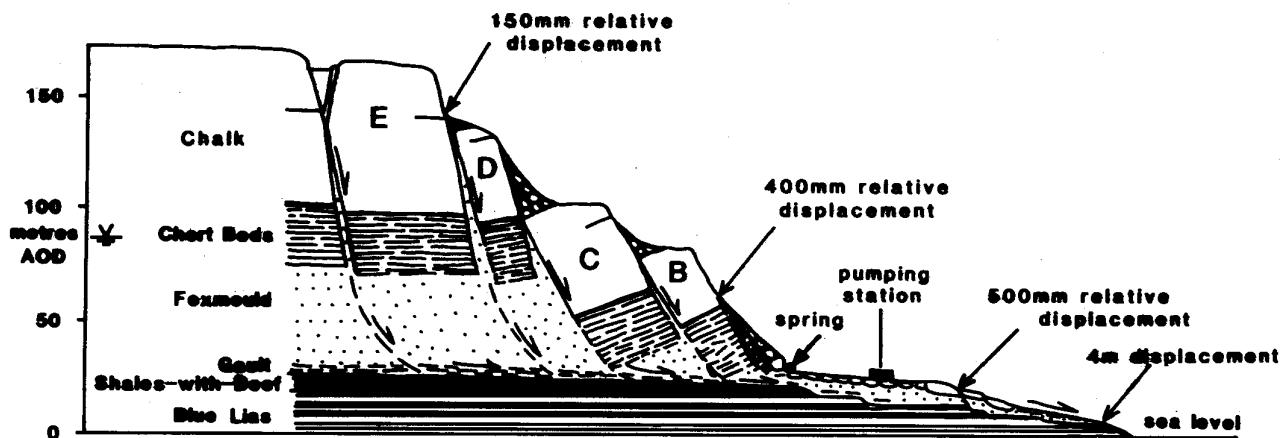
The geological cross section through the pumping station (Figure 3) demonstrates the interpreted mechanisms of landsliding at the site (Grainger *et al.*, 1985). Large blocks of Chalk and Chert Beds became detached along steeply inclined joints, subsided into the partially and temporarily liquefied Foxmould sand and rotated to form the stepped ground surface profile seen today. The orientation of the scarps between the blocks is consistently east-west, suggesting a structural control on the jointing which the scarps follow. It is inferred that basal sliding occurs at the level of the unconformity between the Gault and Shales-with-Beef. The unconformity also acts as a hydrological barrier to downward movement of groundwater (Pitts, 1983).

Figure 3. Cross section through the pumping station (after Grainger et al., 1985) showing positions of displacements recorded in February-March, 1994.

This series of site visits had thus revealed there had been relative movements between the large blocks upslope from the pumping station. Two of these downward displacements, in front of block E (150 mm) and block B (400 mm) were traced laterally to the track and road, distances of 1000 m and 400 m respectively. These movements, consistent over considerable distances, demonstrate the deep-seated nature and vast scale of the major landslide blocks. The movements also explain the coincidental damage to the power lines, water main, spring source and access road first seen on 23 February 1994. The possibility of minor undetected movements seaward of blocks D and C and landward of block E also exists. All of the above movements appeared to achieve at least temporary stability by the beginning of March.

The rear part of the shallow landslide seaward of the pumping station underwent a movement of about 500 mm on its backscarp. Between the backscarp and the toe there appears to have been stretching and the toe had moved seawards relative to the foreshore by approximately 4 m. The major part of these movements took place between 21 February and 24 February.
