## CLIMATE CHANGE, SLOPE STABILITY AND NECESSARY STABILIZATION OF THE ACCESS ROAD, LUNDY ISLAND, BRISTOL CHANNEL, UK

J.N. GRIMES, M. BURROWS AND A. ROBERTSON

Grimes, J.N., Burrows, M. and Robertson, A. 2008. Climate change, slope stability and necessary stabilization of the access road, Lundy Island, Bristol Channel, UK. *Geoscience in South-West England*, **12**, 49-54.

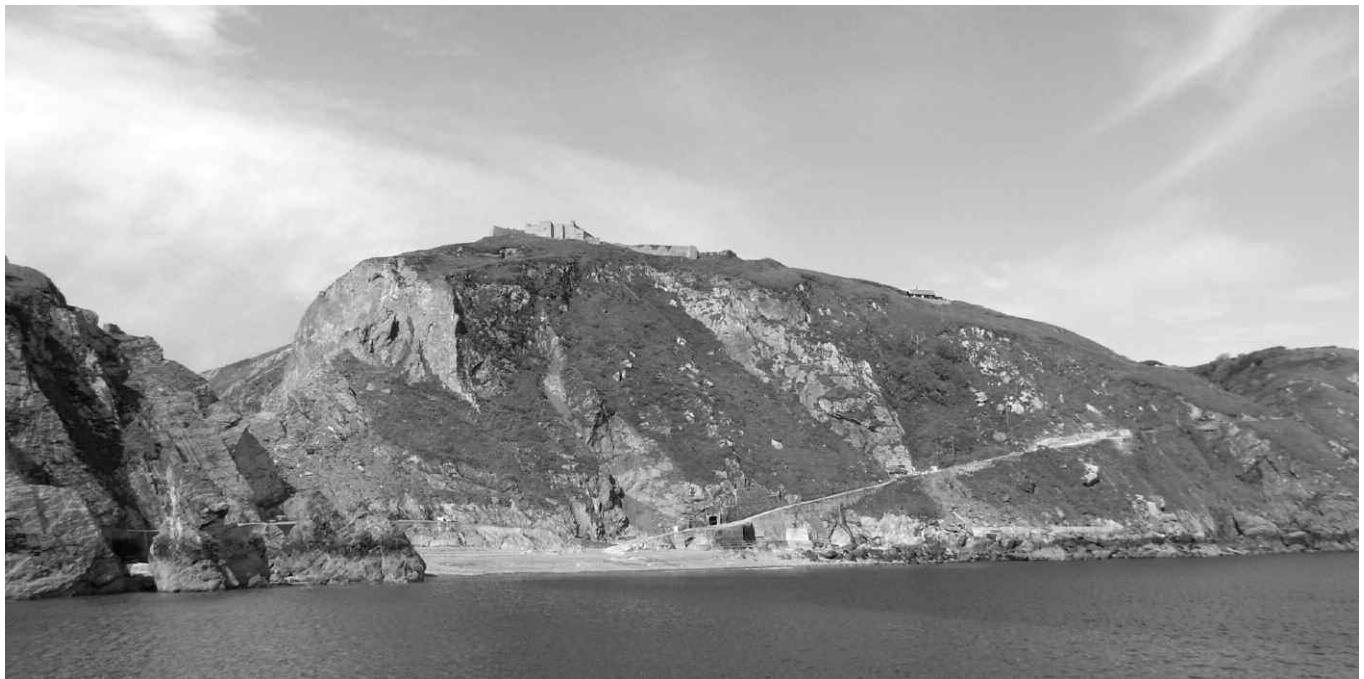
The access road from the old landing beach rises steeply (10°) as shown in Figure 2. In places the seaward side is supported by retaining structures, mainly dry stone walling or gabions. To the landward side the ground rises between 35° to 60° and typically comprises rough vegetated and boulder strewn slopes. There are also several retaining structures, again comprising dry stone walls or gabions, on the uphill side of the road. The section of access road requiring remediation in this current phase of works comprised a 75 m long stretch located some 130 m up track from the old landing beach. The road width varies from 2.7 m to 4.2 m.

Figure 2. Photograph of south-east section of Lundy Island, showing the access road from the old landing beach to "Windy Corner". Lundy Castle is situated on the crest.

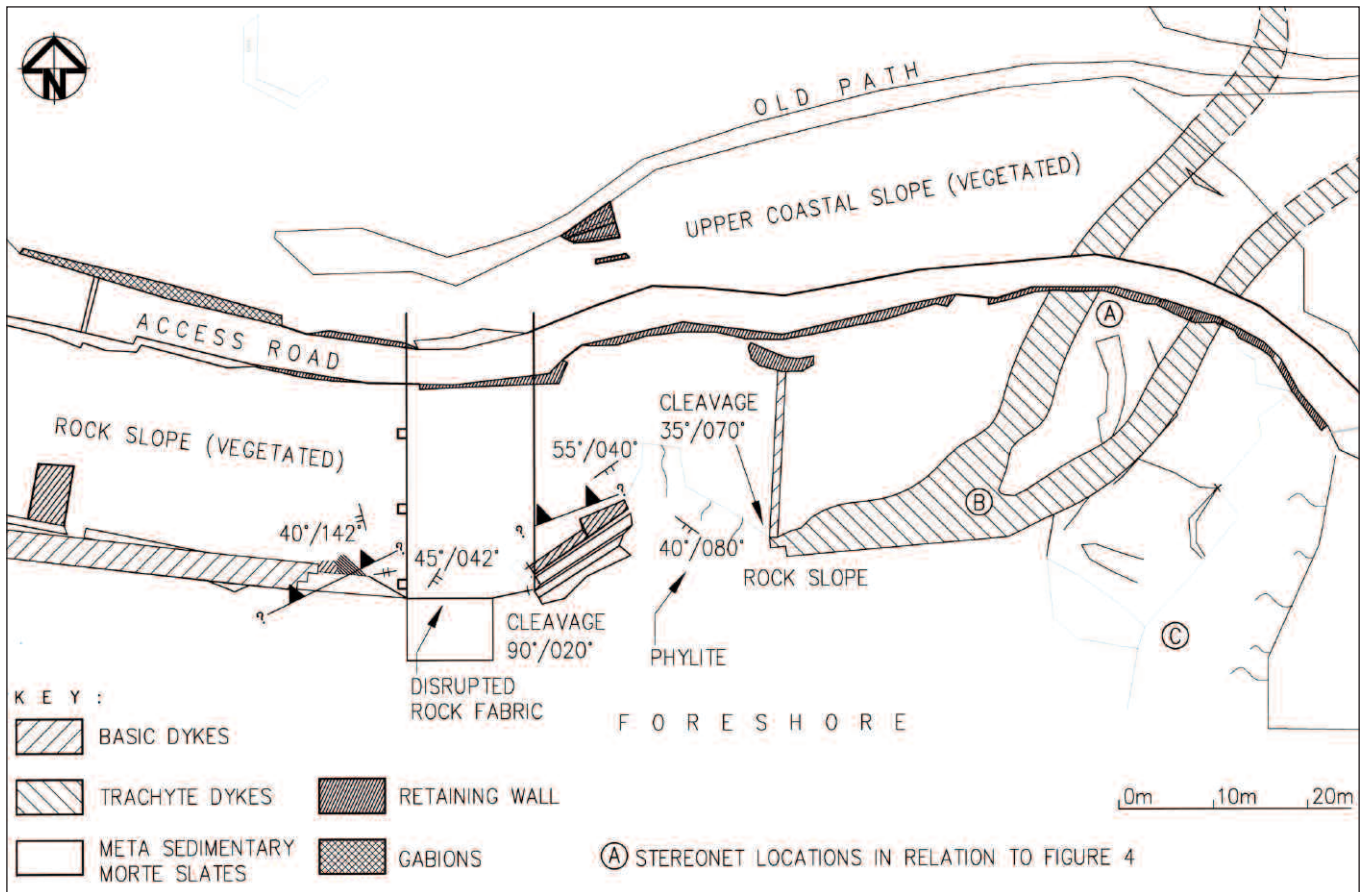
The geology along the access road and foreshore has been investigated. Figure 3 shows the simplified geology map of the recent section of stabilization works. Fieldwork has comprised mapping of the geology at accessible locations and by rope access techniques for the steeper slopes and scarps. During the mapping, engineering geological data was collected including recording of lithologies, discontinuity orientations, physical and geomorphological features and inspection of existing retaining and revetment structures.

Figure 3. Simplified section of geological plan in area of access road stabilization works. Locations A, B and C refer to stereographic plots given in Figure 4.

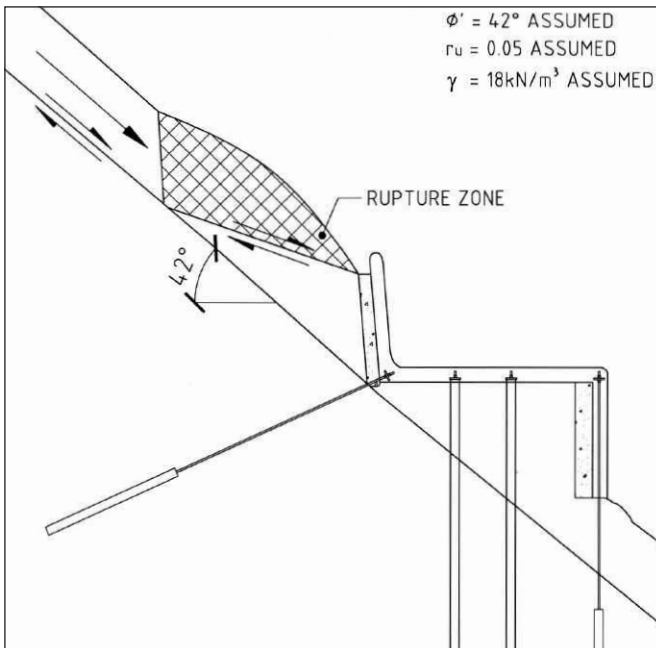
**Figure 6.** Conceptual design for retaining and stabilization works. New road and retaining walls are formed over existing structures and tied back using piles and anchors.

requirement is to build the structure off reasonably competent rock. The structural engineering principle is to utilise the compressive strength in the rock mass, improve the shear strength of the rock mass by anchoring and providing a tensile capacity by the provision of reinforced sprayed concrete facing elements. Using this method, traditionally dug foundations are not necessary.

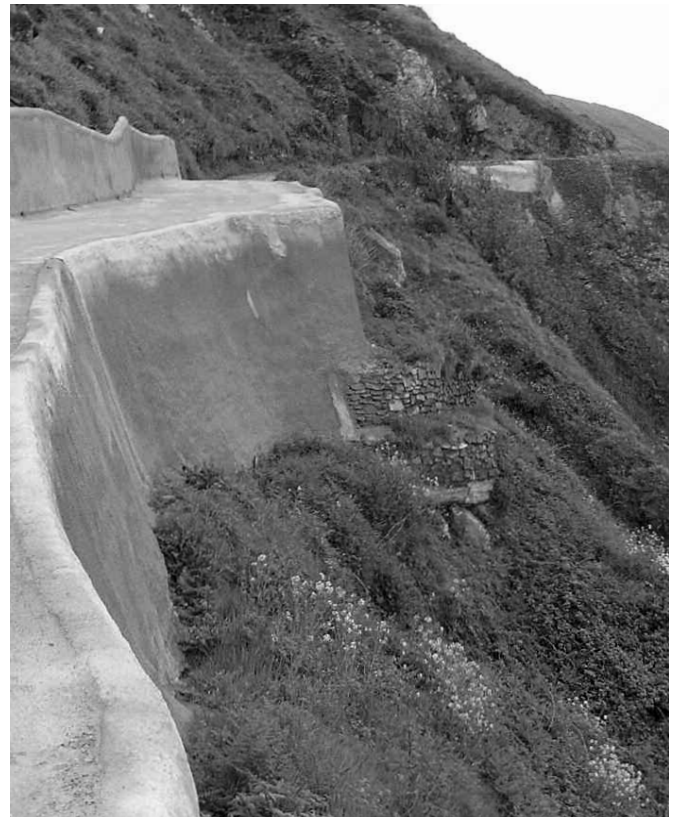
**Figure 7.** Photograph of access road almost one year after works showing Lundy Cabbage in the foreground re-established immediately adjacent to sprayed concrete wall.
