A LEGACY SLOPE FAILURE IN PENLEE QUARRY - A WARNING TO OTHERS

McAllister, R., Walton, G., Coggan, J. and Wetherelt, A. 2013. A legacy slope failure in Penlee Quarry - a warning to others. *Geoscience in South-West England*, **13**, 183-190.

Penlee Quarry has a 90 m high slope which is 50-60 years old and is showing increasing signs of instability with two significant collapses in 2010 and 2011. The latter collapse gave rise to a possible flow slide at the toe and a significant air blast. This paper presents details of the underlying joints controlling ground movements, the investigation of these joints and proposals for remedial works. There are implications for other similar slopes elsewhere in England.

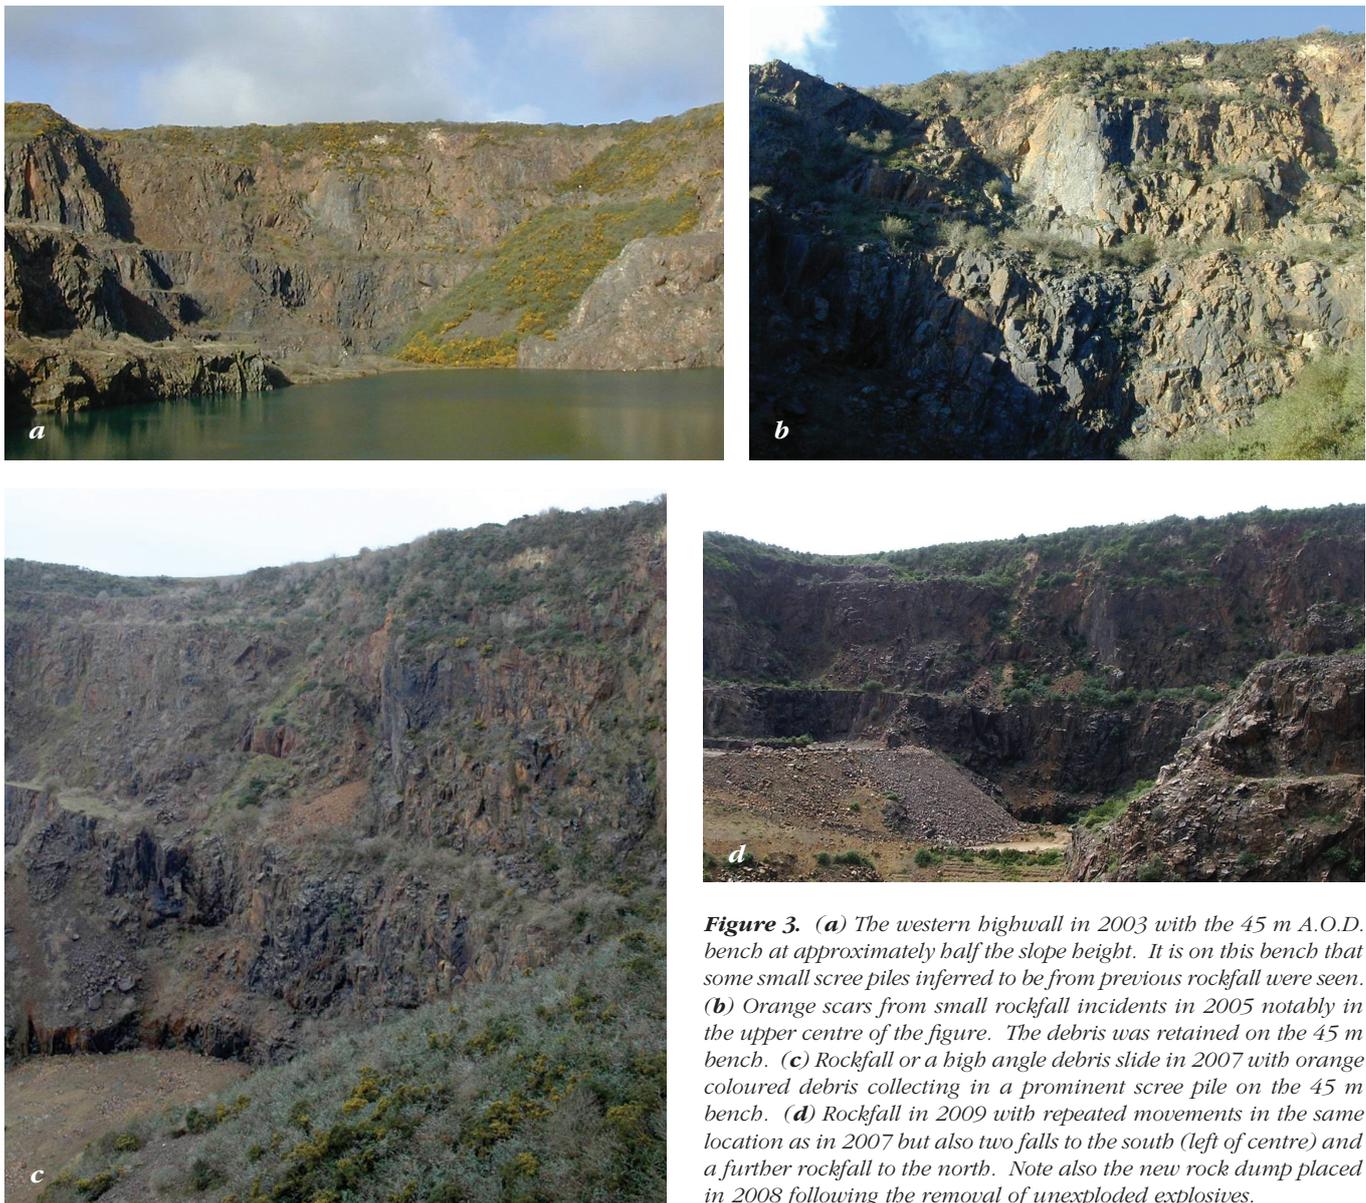
In 2003 in the absence of any quarry records and prior to any significant site works being undertaken for the proposed development, initial geotechnical inspections of the western highwall indicated that there may have been some previous rockfall although none had been reported. Rockfall was apparent from vegetated scree piles observed along sections of the narrow 45 m A.O.D. bench. As a consequence all access to the western face was prohibited and inner and outer barriers constructed. There was however no evidence of recent rockfalls (Figure 3a). In 2005 a rockfall occurred near the centre of the slope with a resulting pale coloured collapse scar and some debris collecting on the 45 m bench (Figure 3b). Further movement occurred in 2007 which could be described as a high angle debris slide (Figure 3c) and again in 2009 at four locations (Figure 3d) resulting in material choking the 45 metre bench.

Figure 3. (a) The western highwall in 2003 with the 45 m A.O.D. bench at approximately half the slope height. It is on this bench that some small scree piles inferred to be from previous rockfall were seen. (b) Orange scars from small rockfall incidents in 2005 notably in the upper centre of the figure. The debris was retained on the 45 m bench. (c) Rockfall or a high angle debris slide in 2007 with orange coloured debris collecting in a prominent scree pile on the 45 m bench. (d) Rockfall in 2009 with repeated movements in the same location as in 2007 but also two falls to the south (left of centre) and a further rockfall to the north. Note also the new rock dump placed in 2008 following the removal of unexploded explosives.

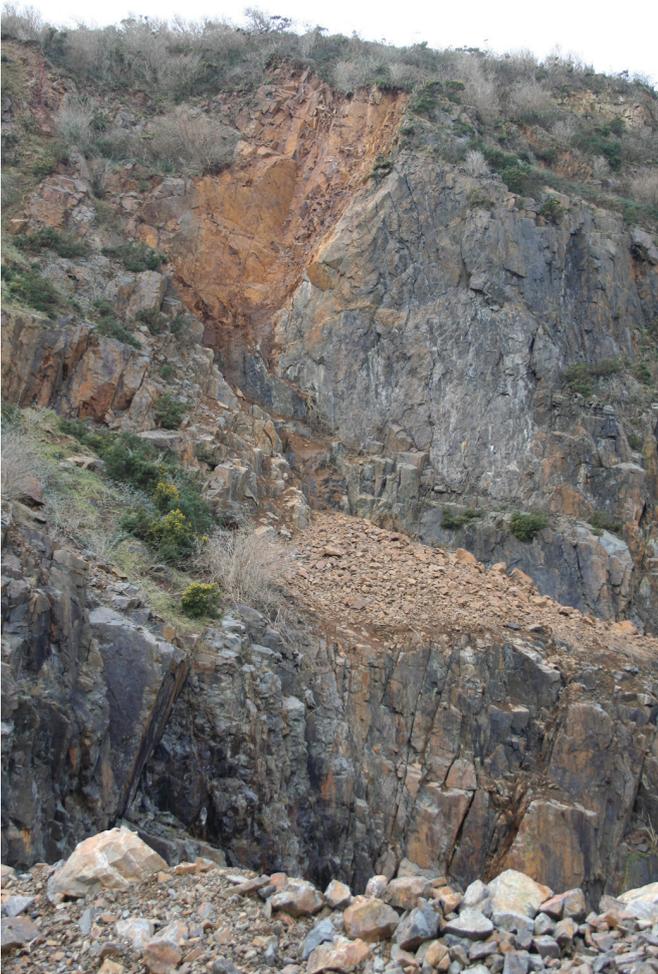
On 25 January 2010, a more significant failure occurred involving a high angle wedge of rock weighing approximately 2,000 t which fell from just below the crest of the highwall (Figure 4). Debris from the face choked the 45 m bench and then fell onto the quarry floor 35 m below. This material also formed a debris scree pile, but stayed within the inner exclusion zone demarcated by a 2 m high bund. Further precautionary measures were established since potential for distinct wedge and toppling failures was identified. However early the following year, a more significant collapse occurred.

Figure 4. The January 2010 wedge failure showing the scar below the crest of the highwall and debris clogging the 45 m bench, with some spillage onto the face below. The release surfaces creating this wedge have been identified using the stereoplot in Figure 10 as Set 2 and Set 4.

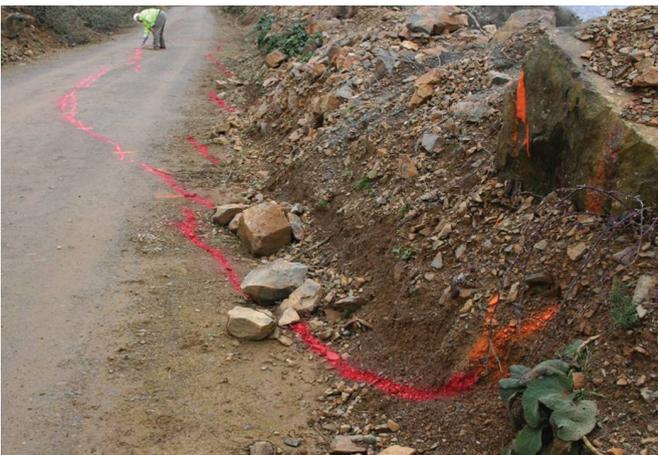
In January 2011 hairline cracking (0.5 mm wide) was identified during routine daily checks along the boundary road immediately behind the edge protection at the crest of the highwall. This cracking continued into February and lengthened to more than 85 metres (Figure 5). At 05:30 hours on 22 February 2011, a collapse of 7-8,000 t occurred leaving a large scar with several clear discontinuity surfaces (Figure 6a). The collapse may have been assisted by extensive freezing and thawing of the face over the winter, followed by heavy rainfall just prior to the collapse. Although the collapse was expected, the nature of the resulting ground movements was not. As noted, the slope toe was significantly less in length than the slope crest and the debris landed in a confined area at the 10 m level. From the resulting piles and spreads of material (Figure 6b) it is apparent that rock fragments and debris travelled large distances from the toe of the slope. A buoyancy aid on the crest of the slope down to the quarry pond, 90 m from the toe, had 5 mm fragments of rock embedded within it (Figure 6c) and the surrounding ground with an area of *c.* 1.0 ha up to a level of 35 m A.O.D., was covered in a thick layer of dust. Two distinct ridges of small rock debris (<10 kg) were formed on either side of what appears to have been a possible flow slide although there is little doubt that much of the finer debris was dispersed by the air blast.

Figure 5. Cracks in the western quarry access road being marked out in January 2011 to aid the identification of further movements.

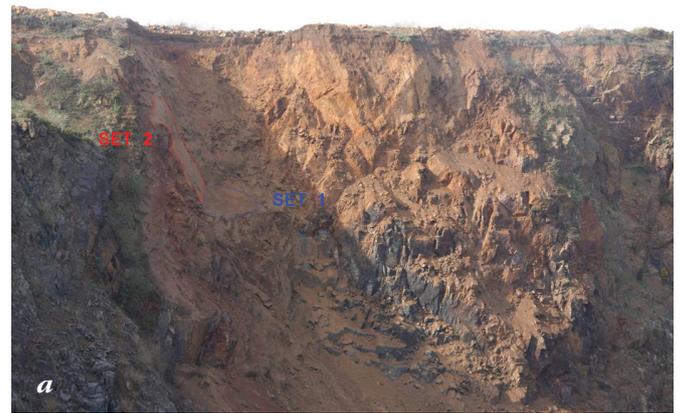
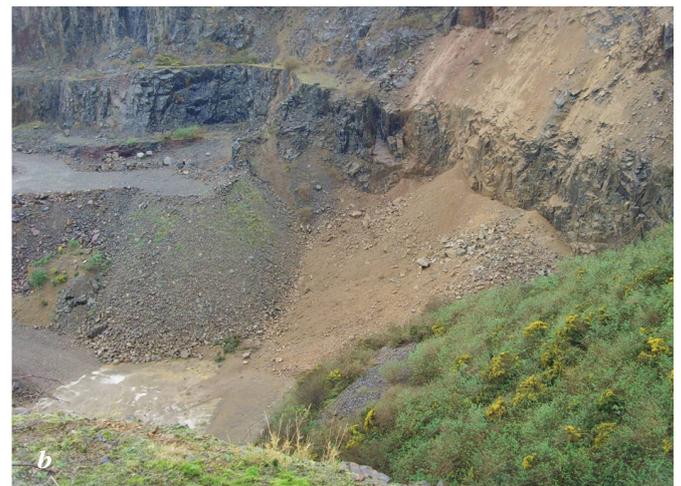
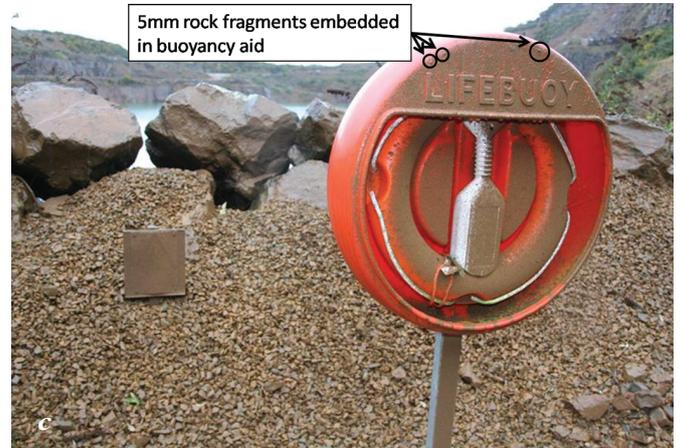
orientation data on a stereoplot four dominant joint sets were identified, as shown in Figure 10. Kinematic analysis of the data suggests that Joint Set 1 forms potential planar failure surfaces or basal planes for direct toppling, in addition to the potential wedge failure from intersections of joint sets identified previously. It is unclear whether the 2011 collapse was a result of planar failure (Set 1) or toppling failure (Sets 2

Figure 6. (a) Scar of collapse in February 2011 showing discontinuities inclined out of the highwall (Set 1) and release surfaces similar in alignment to those of the 2010 collapse (Set 2). Figure 10 shows the stereoplot derived from the laser scan of this face with allocation of the discontinuity sets. (b) The debris pile at the toe of the February 2011 collapse. Photograph taken from Laser scan position 3 (see Figure 8). (c) A buoyancy aid at a distance of 90 m from the toe of the highwall with 5 mm rock fragments embedded from the resulting air blast following the collapse. Figure 7 shows the location of the buoyancy aid in relation to the slope face.

and 3) or a combination of both (with Set 1 forming the basal plane); however the risk of further failure was apparent with movements extending beyond the site boundary behind the crest of the slope. The Split FX analysis primarily focussed on identifying the orientation characteristics of the discontinuities although it is also possible to establish other parameters such as persistence and spacing of the respective sets.

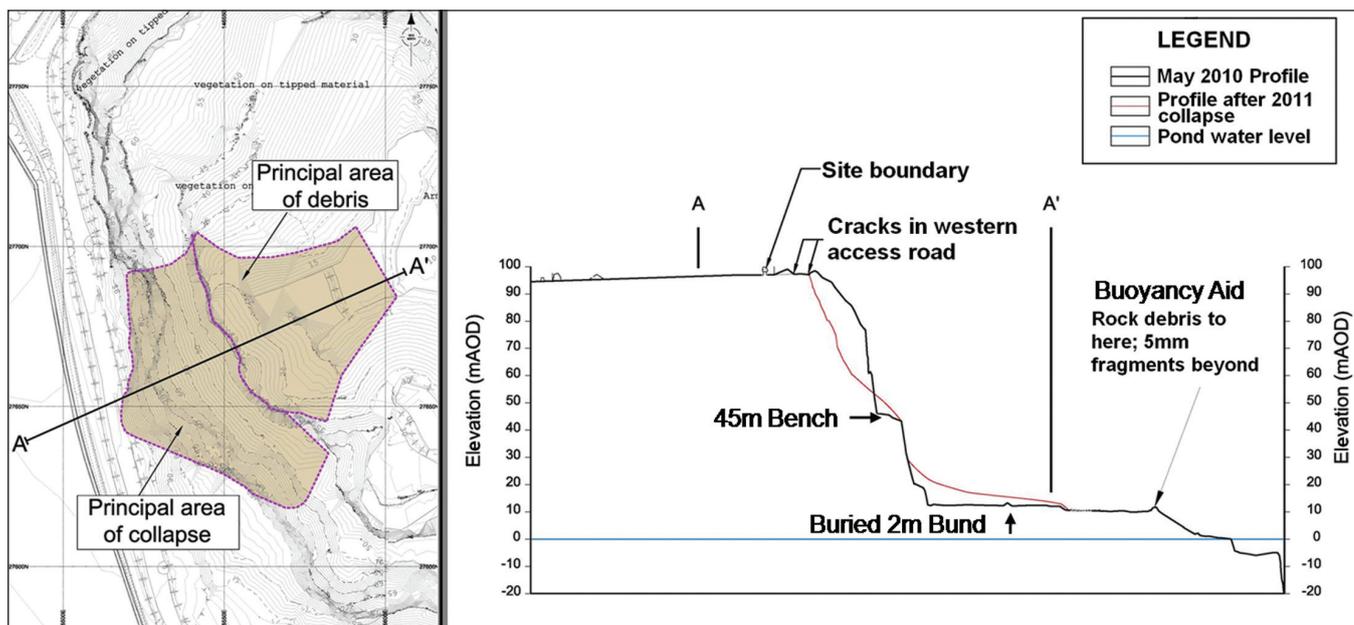
The plan and cross-section in Figure 7 show the extent of the collapse scar and debris pile, highlighting the debris pile with a shallow gradient of 7°. The positions of the choked 45 m bench, the buried inner exclusion barrier (2 m high bund) and position of the buoyancy aid are indicated. The collapse scar extended 35 m along the perimeter road, but the cracking extended more than 85 m along the road in places more than 10 m behind the crest of the slope. Subsequent calculations have shown that a further 40-60,000 t of rock could imminently collapse in relation to the discontinuity patterns that had become apparent. In the context of what occurred on the morning of 22 February there appeared to be some potential for even more significant flow slide/air blast phenomena and as such the event was reported under RIDDOR (Anon, 1996) as clearly this was a dangerous occurrence of relevance to this and other operations.

Figure 7. A plan and cross-section of the 2011 collapse showing movements in relation to the site boundary and the western quarry access road.

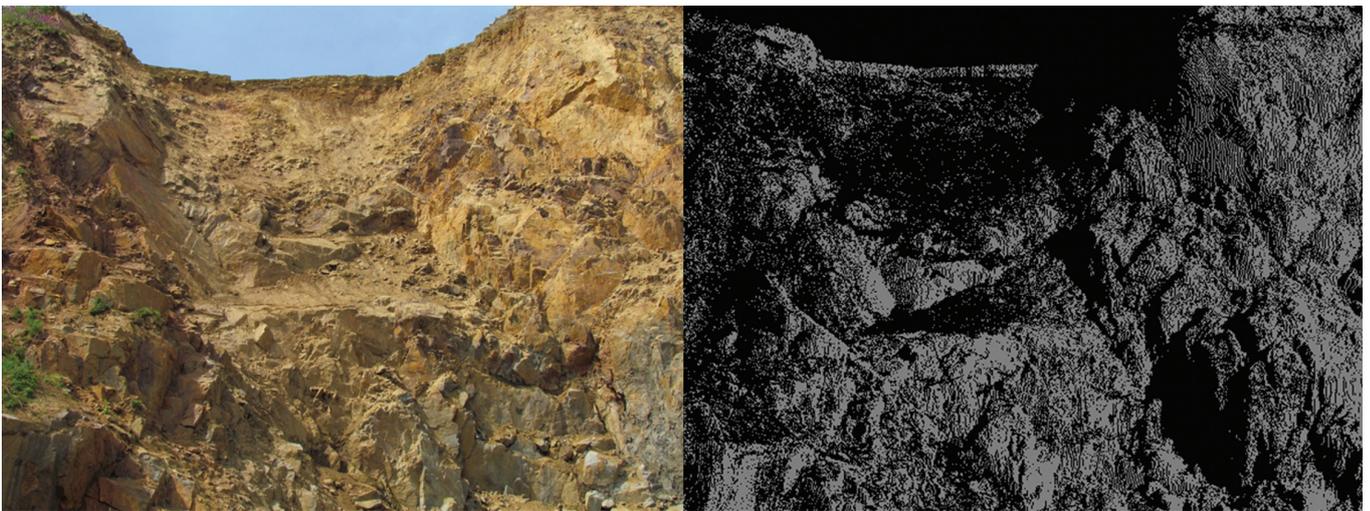
Figure 9 shows a photograph and point cloud image of the 2011 failure scar on the upper region of the western face. The point cloud data were analysed using Split FX to identify the dip and dip direction of identified surfaces that represent individual discontinuities within the rock mass. These surfaces or ‘patches’ were manually identified rather than relying on automated routines. This involved rotating the point cloud until it was perpendicular to the identified plane before the patch is inserted to ensure the correct orientation of the patch. It should be noted patches cannot be inserted on shadows on the point cloud as these areas have no points. By representing this

Figure 9. Split FX software point cloud image of the upper region of the western face from the 2011 scanning survey (right), and a photograph of the same slope (left). Figure 10 shows the stereoplot derived from the laser scanning of this face.

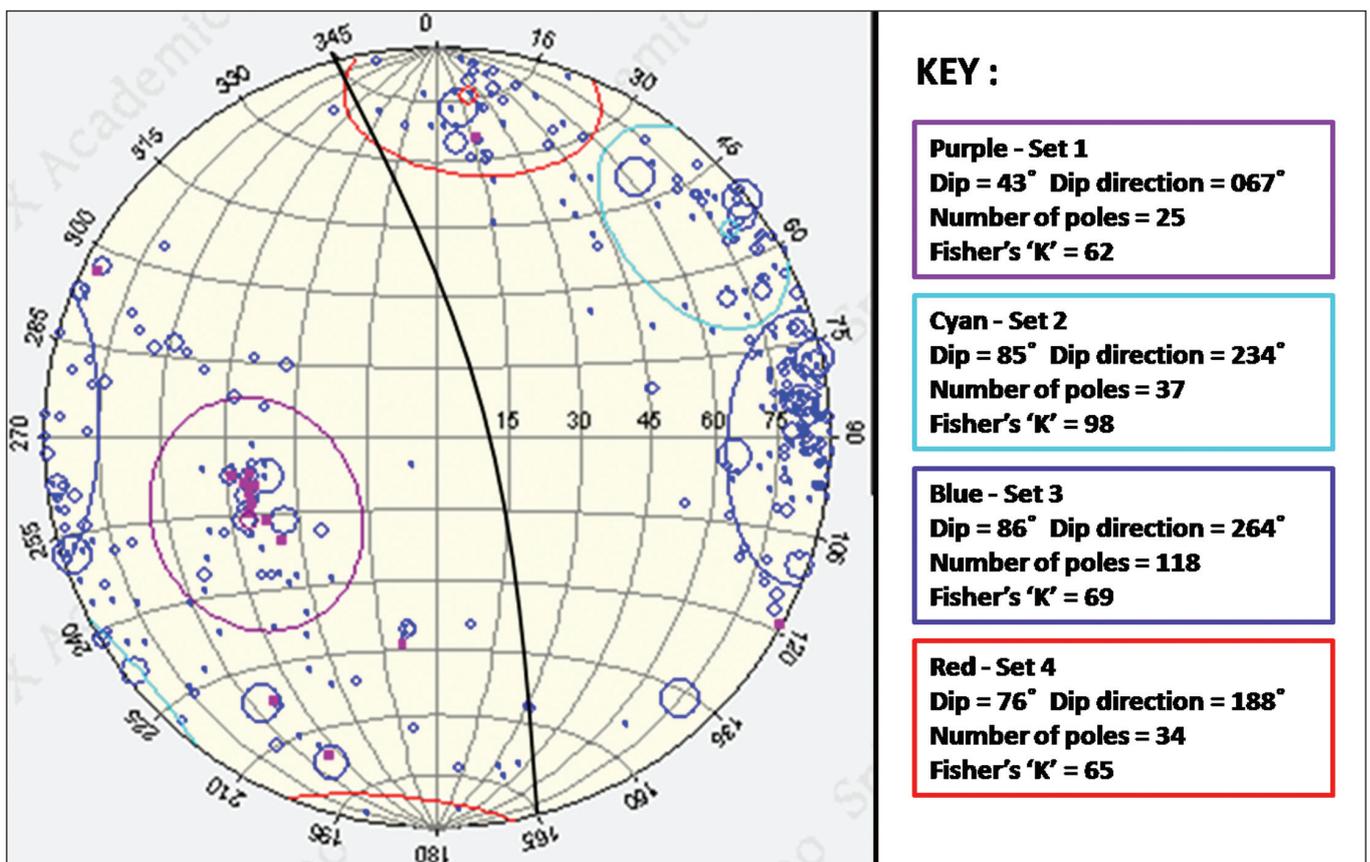
Figure 10. The stereoplot based on manually inserted 'patches' onto the point cloud image shown in Figure 9 for the 2011 collapse. Joint Set 1 with a general dip of 43° in the direction of 067° was found to be a significant structural element to be accommodated in the proposed remedial works.

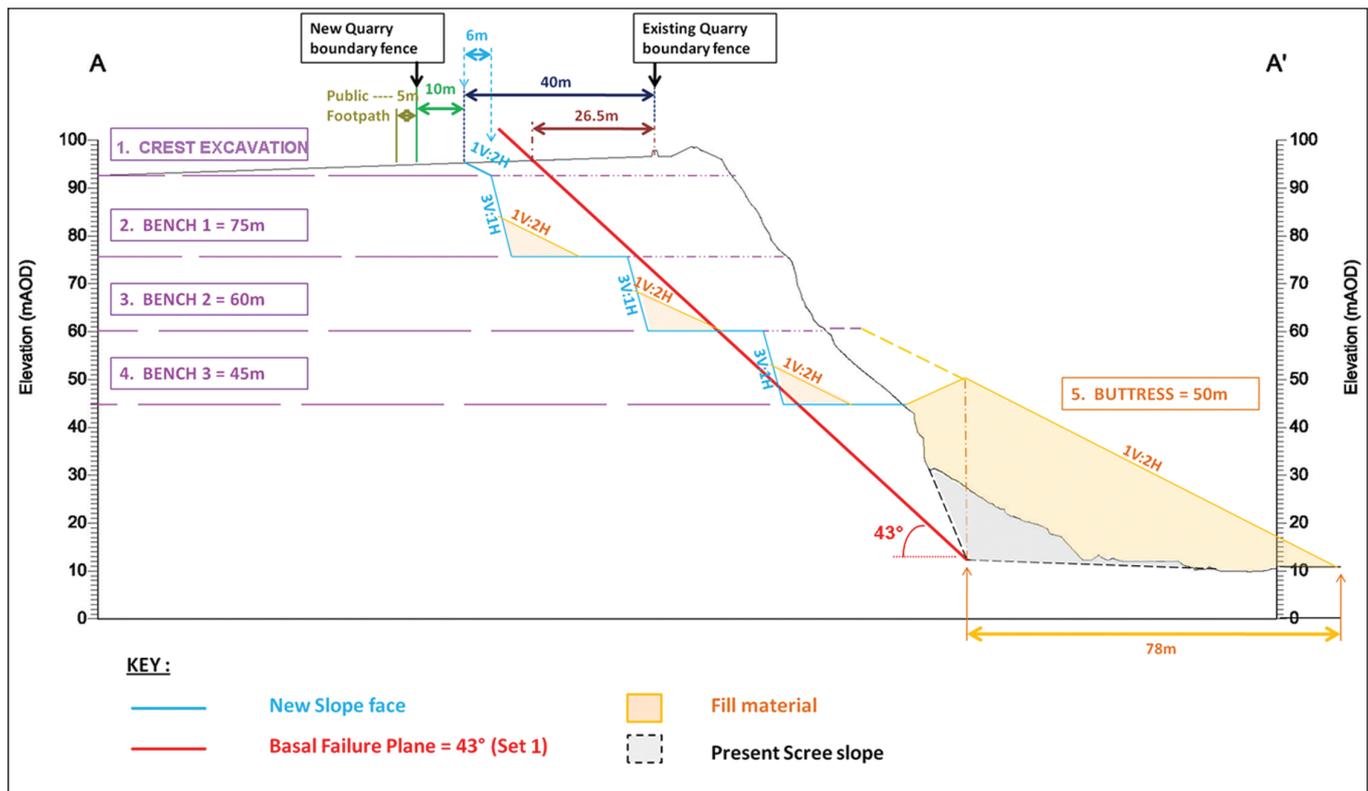
Projections of discontinuity Set 1, assuming a worst case scenario, as shown in Figure 11 indicate that movements could extend beyond the boundary of the quarry into the land to the west depending on the inferred discontinuity persistence. In

Figure 11. A cross-section showing the proposed stabilisation works using bench excavation and buttressing up to 45 m A.O.D. and buttressing of each excavated bench. (N.B. this cross-section is along line A-A' in Figure 12, but extends c. 90 m to the SW and c. 30 m to the NE).

The excavation proposed shown in Figures 11 and 12 extends from the western limits of the proposed armourstone quarry in the south east to the northern end of the western highwall. This aims to provide access and space for ramps, a safe replacement road behind the landslip area and haul roads down to the proposed buttress area incorporating the existing buttress from the 2008/9 works.

The proposed benching system comprises benches at the 45, 60 and 75 m A.O.D. levels and a minor 'rockhead bench' at 90 m A.O.D. The bench heights are 15 m and the basic bench widths nominally 25 m wide. This configuration ensures that the lowest angled adversely orientated discontinuities within

the rock mass, as identified in the investigations following the 2011 collapse, are only undercut at bench level and not by multiple benches. The levels and configurations of benching are modified at the northern and southern ends of the excavation to accommodate existing ground levels. Bench faces are assumed to be 1 to 3 (horizontal to vertical) but would be modified by face dressing, especially at the crest, and by debris placed at the toe of each bench reaching up to a third to half the bench height. Benches would have 2 m high outer edge protection and would be covered with roughly sorted material generally of less than 300 mm. Allowing for break-back and dressing slope crests, this would give a bench

between the edge protection and the buttress material of about 5 m for a 20 m-wide basic bench. Limited rock excavation would occur between the 60 m and the 45 m level, but a significant buttress bench would be formed of excavated material at the 45 m level. The total excavation volume of material to form the overall benching would be 346,000 m³.

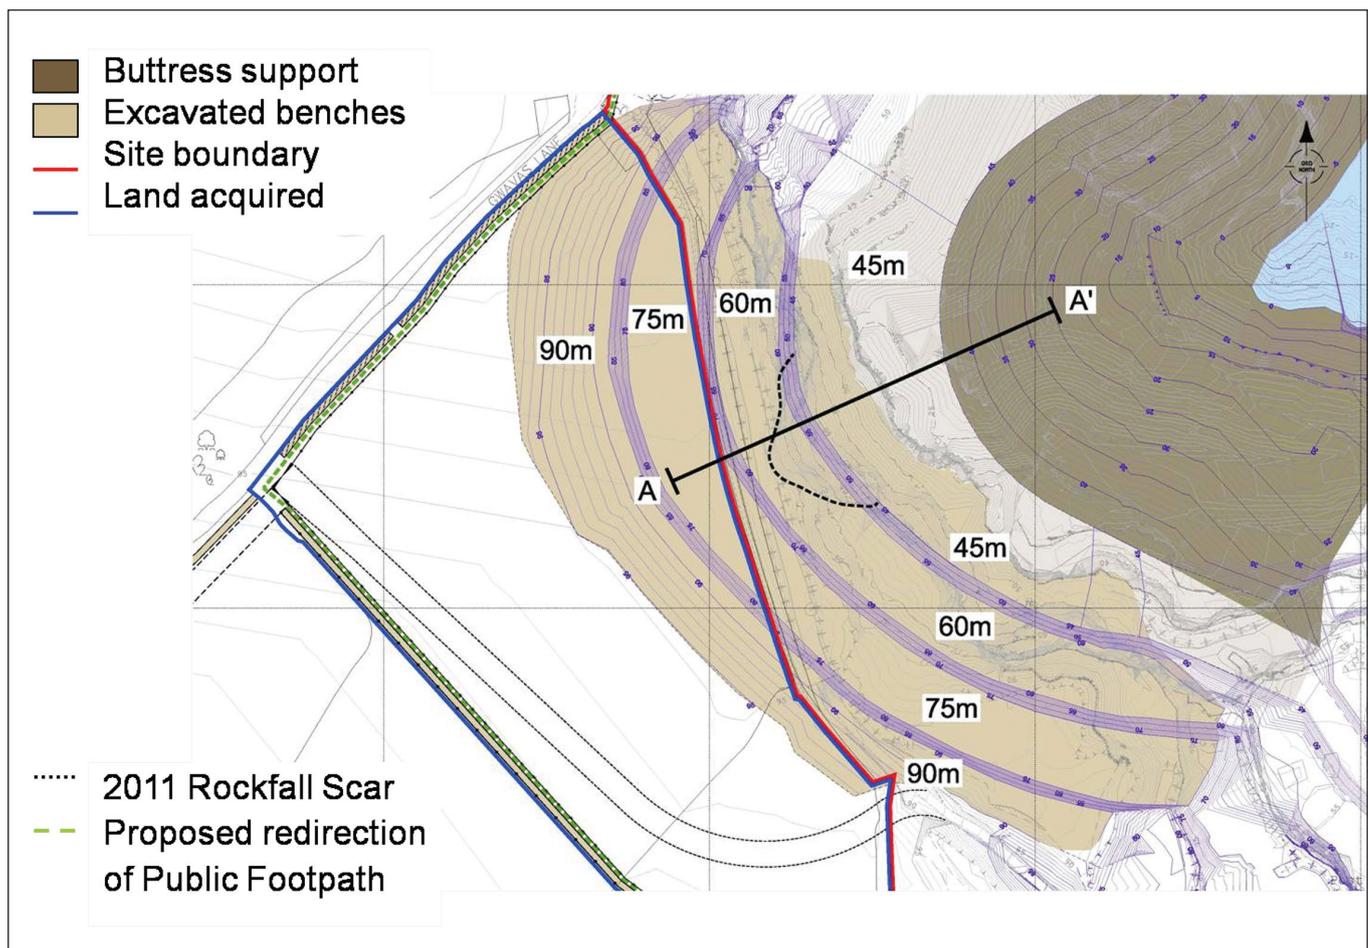
Figure 12. A plan showing the proposed excavation benching, buttressing and the likely diversion of the public footpath. (N.B. the cross-section for line A-A' is shown in Figure 7).

As designed, this system of benching and buttressing allows for excavation to commence at the southern/south eastern end of the relevant area and to progress into and behind the landslip area where there is active cracking. Excavated material would be hauled via temporary ramps to the existing buttress, which would be progressively raised and extended to form the buttress shown in Figures 11 and 12.
