## THE RELATION BETWEEN COASTAL LANDSLIDE ACTIVITY AT PINHAY, EAST DEVON AND RAINFALL AND GROUNDWATER LEVELS

P. GRAINGER, P.G. KALAUGHER AND S. KIRK

Grainger, P., Kalaugher, P.G. and Kirk, S. 1996. The relation between coastal landslide activity at Pinhay, east Devon and rainfall and groundwater levels. *Proceedings of the Ussher Society*, 9, 012-016.

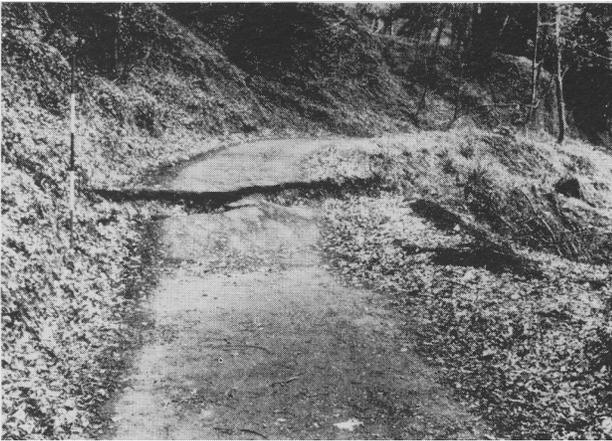
Figure 5: Disruption of the access road in February 1994 where crossed by the scarp at the base of block B (photograph taken on 7 March 1994).
