LANDSLIDE MECHANISMS IN THE AXMOUTH TO LYME REGIS UNDERCLIFFS NATIONAL NATURE RESERVE, DEVON, UK

R.W. GALLOIS

Gallois, R.W. 2014. Landslide mechanisms in the Axmouth to Lyme Regis Undercliffs National Nature Reserve, Devon, UK. *Geoscience in South-West England*, **13**, 345–359.

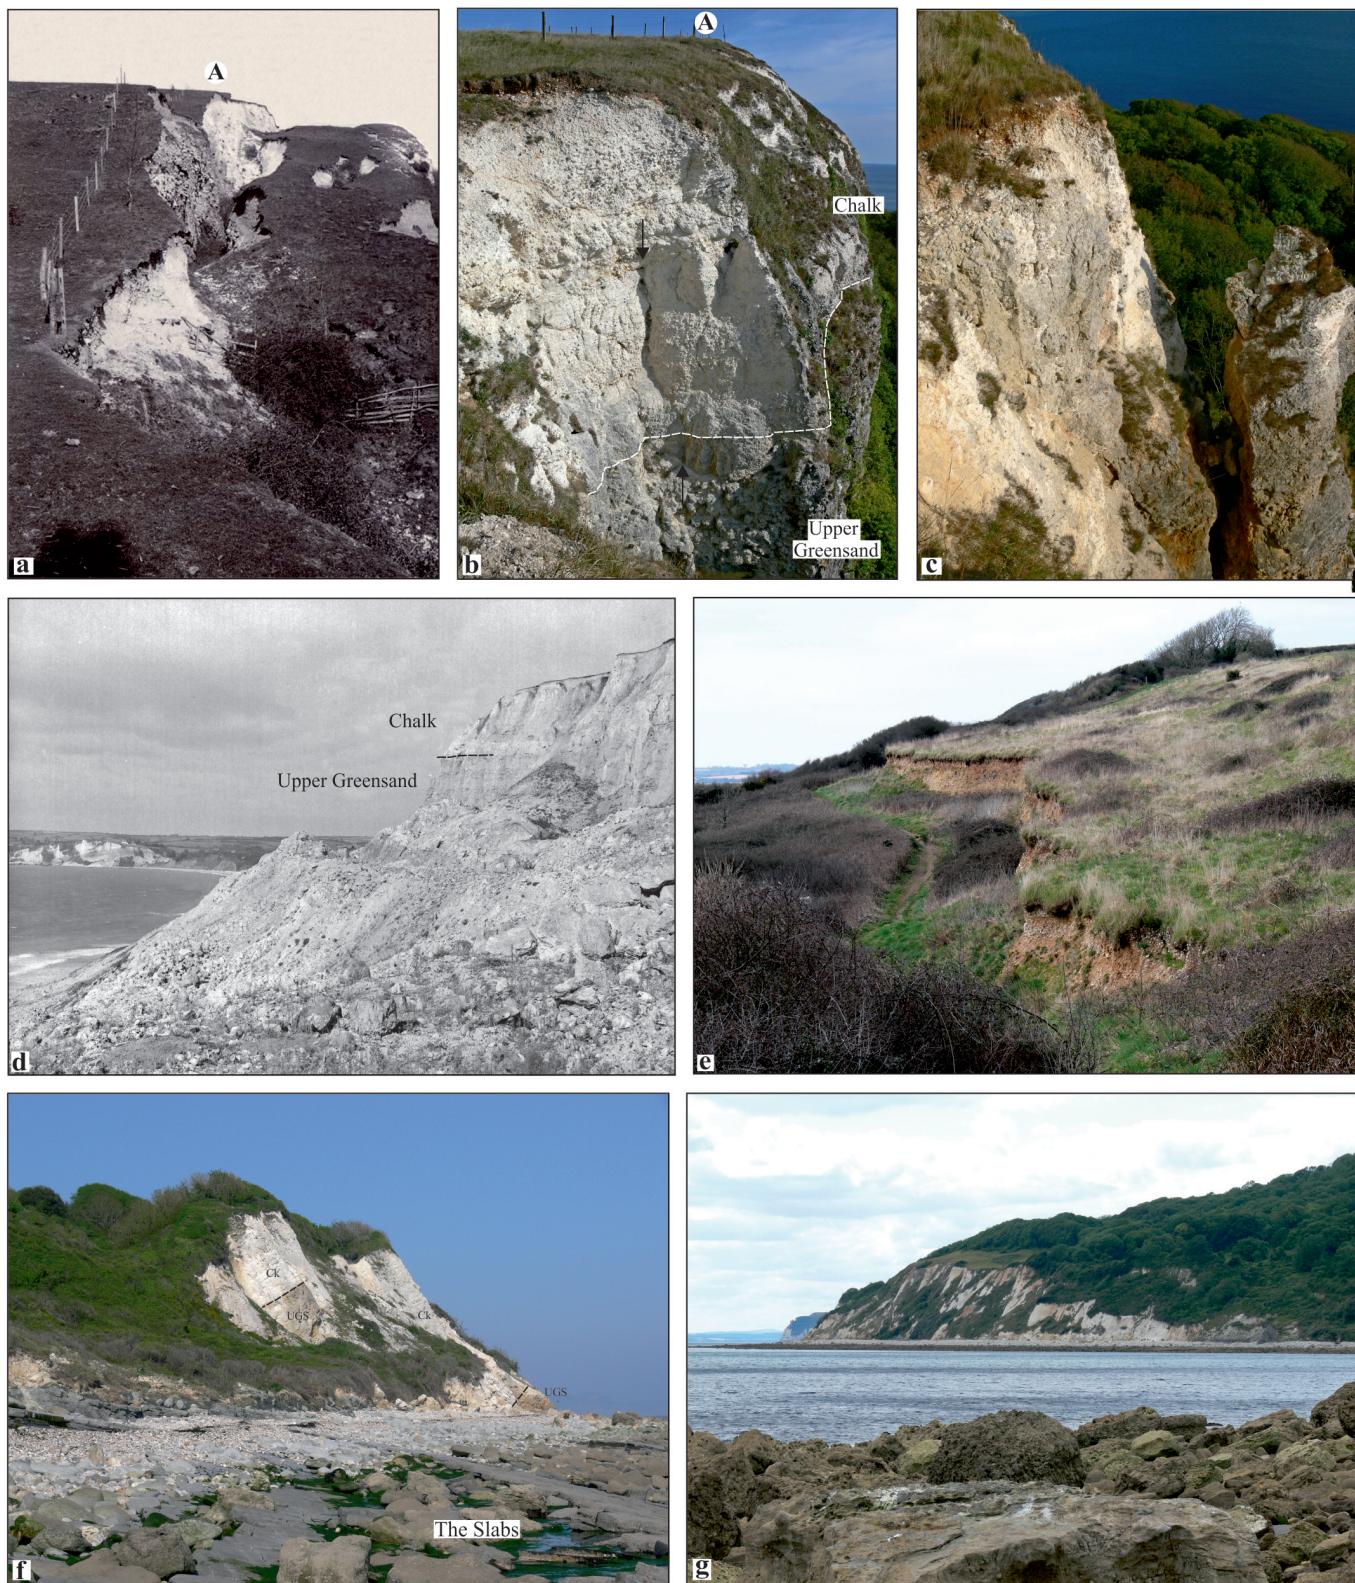
Figure 4. (a) View E of the western end of Haven Cliff showing the 'cleft' that separated a detached mass of Upper Greensand and Chalk from the in situ cliff. Photographed by T.W. Reader in 1914, British Geological Survey (BGS) No. P252446, copyright NERC. (b) Tension crack (arrowed) in Upper Greensand and Holywell Nodular Chalk, western end of Haven Cliff [SY 2585 8983] in 2012, view E. The crest of the cliff A is that shown in (a). The crack does not penetrate the partially decalcified chalk at the top of the sections which acts as a weakly consolidated soil. (c) Detached pillar of in situ Upper Greensand and Chalk, c. 15 m high, Dowlands Cliff [SY 2846 8961]. (d) Haven Cliff photographed by Frank Rhodes in 1934 shortly after a large rock fall in the Upper Greensand and Chalk. View W towards Seaton. The detached mass shown in (a) may have collapsed at this time. Reproduced with the permission of BGS, copyright NERC. (e) Subsidence of the Coastal Path at the eastern end of the Haven Landslide complex [SY 2663 8973] in the unusually wet winter of 2000–2001. View W from 50 m W of the western entrance to the NNR. (f) Back tilted masses of Upper Greensand and Chalk at the seaward edge of the Dowlands Landslide complex [SY 2878 8945] that may have secondarily moved along failure surfaces in seaward dipping Shales-with-Beef. In situ limestone beds in the basal part of the Shales-with-Beef (foreground) are within an E–W trending fault zone. View E from the eastern end of The Slabs. (g) View W across Chariton Bay from the apron of Upper Greensand blocks at Humble Point towards The Plateau, a large detached mass of Cretaceous rocks in the Dowlands Landslide complex.

At some time prior to 1914, a mass of Upper Greensand and Chalk up to c. 150 m long became detached from the western end of Haven Cliff (Figure 4a) and subsided up to 15 m. This is presumed to have been a primary translational failure in a thin mudstone close above the base of the Upper Greensand (Figure 5a) along one or more joints running parallel to the cliff face. This was followed by major falls in the same area and eastwards from there in the early 1930s, at least one of which was the secondary collapse of the detached mass which gave rise to the rugged topography known locally as the Elephants' Graveyard (Figure 3c). The Ordnance Survey 1:2,500 scale map of 1931 shows c. 600 m of the outcrop of the Mercia Mudstone in Haven Sea Cliff obscured by landslide debris. The Geological Survey Photographer was despatched to the site in 1934 and produced a series of pictures that show large areas of relatively fresh debris covering the slopes between Haven Cliff and the sea cliff (Figure 4d). Arber (1940) noted that at the eastern end of Haven Cliff "great masses of Upper Greensand and Chalk have fallen on to the shore and become banked up against the cliff". Given the speed at which such debris is removed by the sea, this must have been a relatively recent event at the time of her writing (1938). The most recent documented events have been at the eastern end of the complex where Grainger (2000-2005) recorded the formation of a new back scarp at some time between 1957 and 1962. An additional landslide scarp was formed inland of the first in 2001 following what was at that time the second wettest year since records began (Table 1). This now forms the inland edge of the Undercliffs over a distance of c. 200 m in which the strata on its seaward side have subsided by up to 2.5 m (Figure 4e). A geological section through the eastern part of the complex is shown in Figure 5a. There is no visible seaward dip in the Upper Greensand and Chalk in Haven Cliff that might explain the estimated difference in the height of c. 13 m in the estimated positions of the basal Cretaceous unconformity below Haven Cliff and at the top of Haven Sea Cliff. The difference is therefore presumed to be due to faulting.

Comparison with the mechanisms by which masses of Cretaceous rocks became detached from the cliffs at Haven Cliff (Figure 4a) and Pinhay Cliff (see below) suggests that the gap between Goat Island and the *in situ* cliff opened up along an E–W trending fracture zone as a result of a translational failure close to the base of the Cretaceous rocks. Pitts (1974) referred to an unpublished report which suggested that the initial fracture might have formed along the line of a fault. There is no published field evidence to support this suggestion, but several E–W trending faults pass beneath the landslides in this part of the NNR (Gallois, 2010, figure 9), and the Chasm is

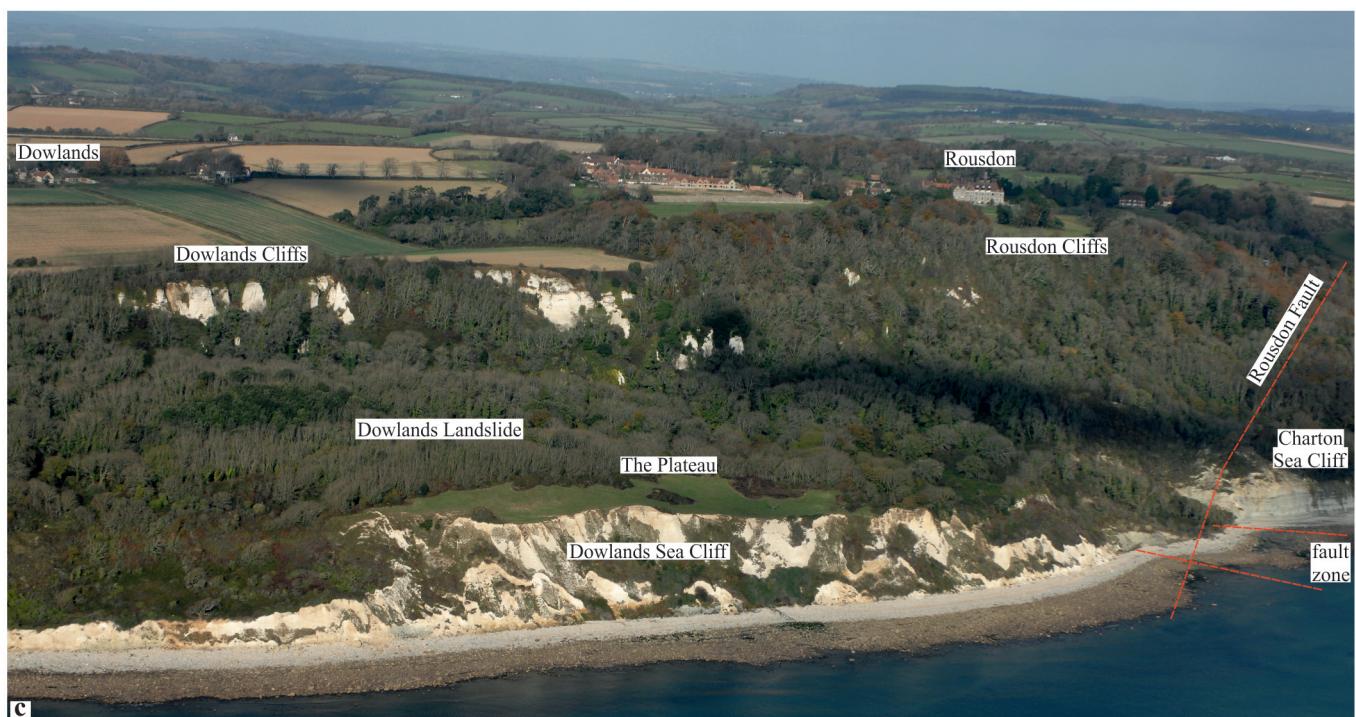
Figure 6. (a) Charton Bay viewed from the sea in 1840 (part of Plate II of Conybeare et al. (1840)). (b) Geological interpretation of (a). (c) Oblique air photograph of eastern part of the Dowlands Landslide complex taken by Paul Witney, BGS in February, 2008. Reproduced with the permission of BGS, copyright NERC.

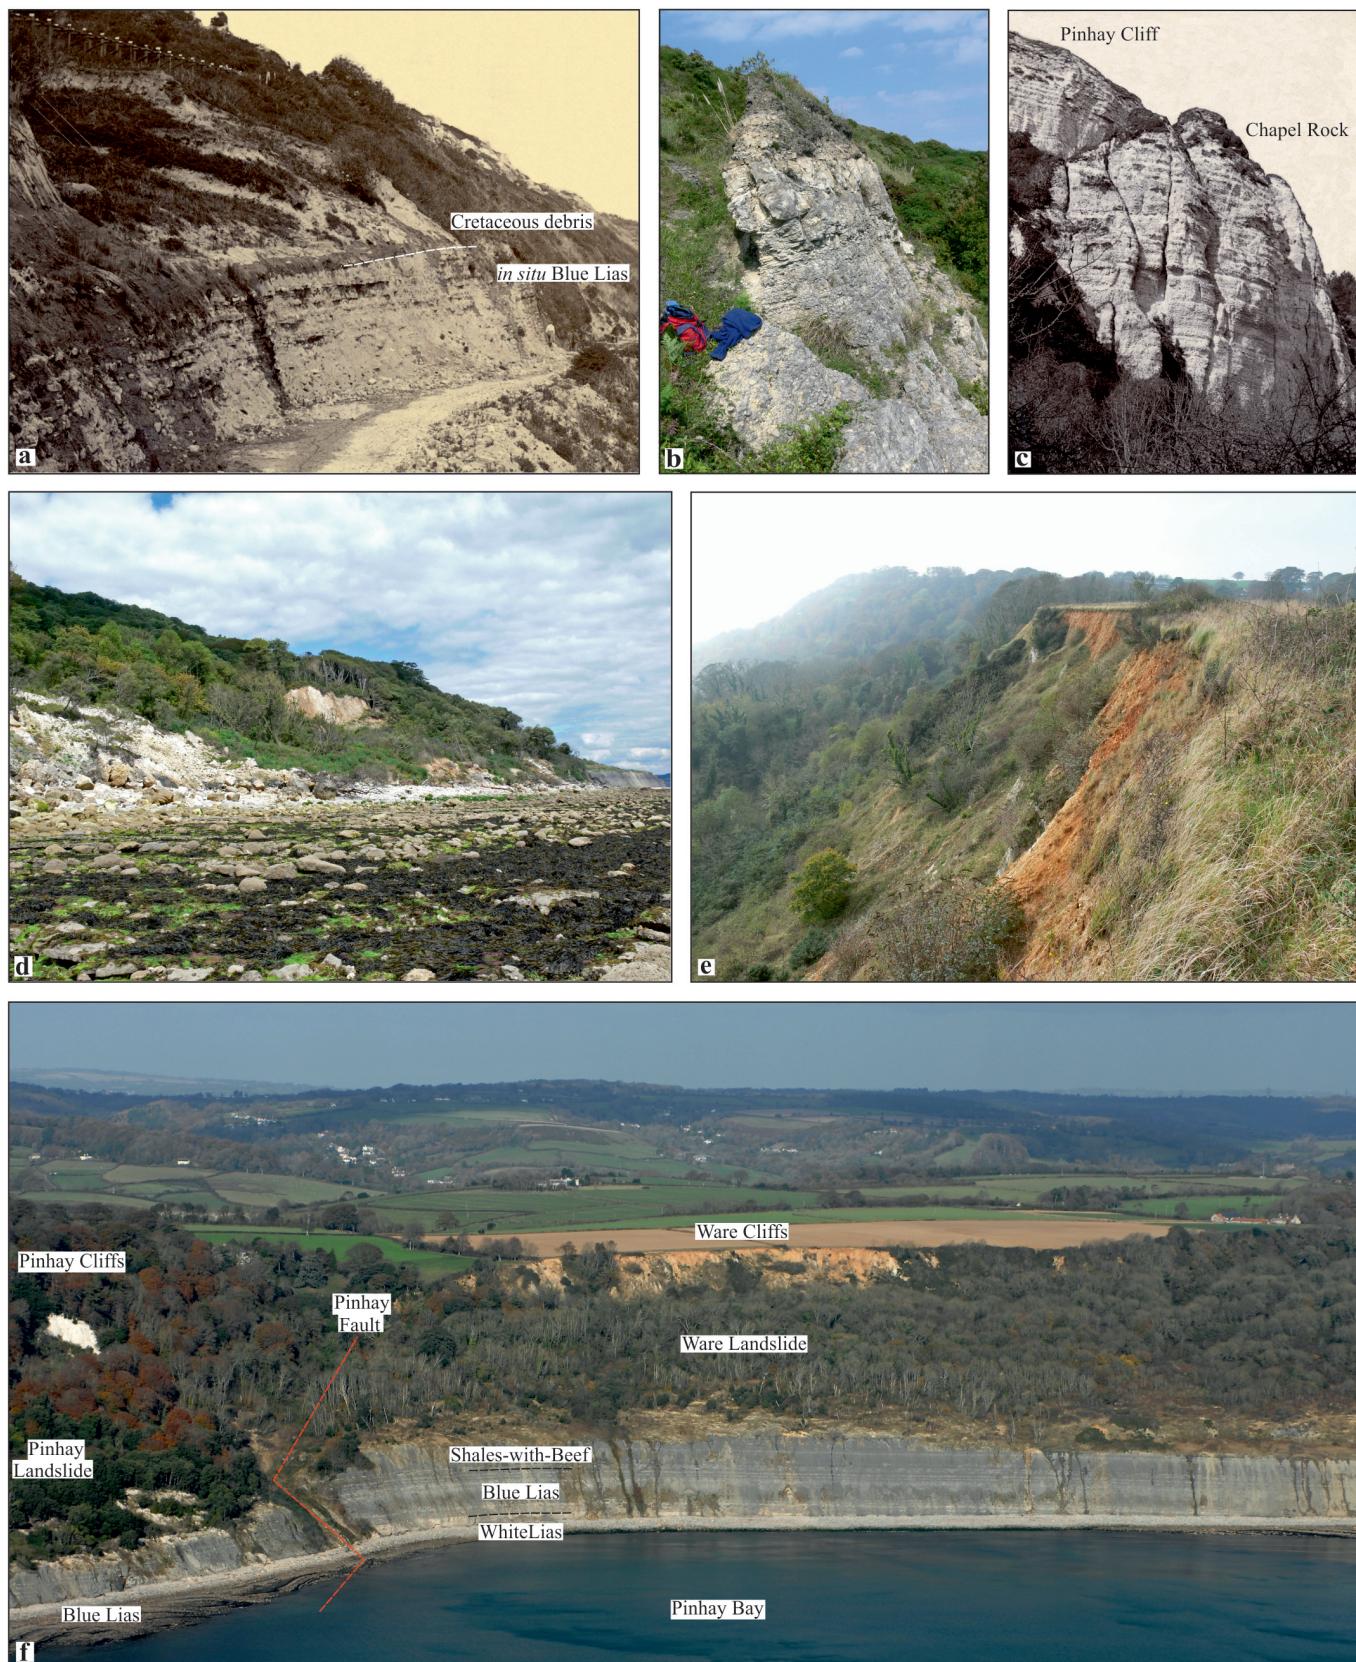
Figure 9. (a) Rousdon cart road [SY 2998 9020] cut in undisturbed Blue Lias. The unconformity at the base of the Cretaceous is probably marked by the seepage line at the top of the cutting. Photographed by S. H. Reynolds in 1912; BGS No. P238889, copyright NERC. (b) Intact block of back tilted White Lias [SY 2997 9014] which has moved downslope c. 1-2 m as the result of shallow-seated landslides in the underlying Westbury Mudstone. Western end on the Whitlands Landslide above Charlton Bay. (c) Chapel Rock [SY 3117 9063], a detached mass of Chalk that separated from Pinhay Cliffs at some time prior to the mid 16th Century. Photographed by T.W. Reader in 1914, BGS P252433, copyright NERC. (d) View NE across the Blue Lias beach outcrop at the seaward edge of the Pinhay Landslide complex towards the active landslides in Cretaceous debris below the former Pinhay Pumping Station, October 2009. Large movements during unusually wet weather in 2001 over-rode a low cliff in Blue Lias and covered the upper part of the intertidal area. (e) View W of shallow-seated, collapse of Clay-with-flints debris at the western end of Ware Cliffs [SY 3203 9120]. (f) Oblique air photograph, view across Pinhay Bay and the Ware Landslide complex taken by Paul Witney, BGS in February, 2008. Reproduced with the permission of BGS, copyright NERC.

Small failures in the Pinhay Landslide complex include the frequent flows of mud-sand mixtures derived from the Lias and Upper Greensand in the area around the former Pinhay Pumping Station (Figure 9a). Similar small movements have occurred in all the landslide complexes in the NNR. Those in the Pinhay complex have been better documented because springs that emerge from displaced Cretaceous rocks in the
