FIELD EXCURSION TO EXAMINE THE SEDIMENTOLOGY AND ENGINEERING GEOLOGY OF PERMIAN STRATA IN THE TORBAY AREA, 5TH JANUARY, 2015

McVicar Wright, S.E., Gould, R. and Scrivener, R.C. 2015. Field excursion to examine the sedimentology and engineering geology of Permian strata in the Torbay area, 5th January, 2015. *Geoscience in South-West England*, **13**, 491-494.

The purpose of the field excursion was to examine the sedimentology and engineering geology of Permian strata cropping out in the Torbay area. The trip included visits to four locations where a range of sedimentary features and engineering problems and solutions were evident.

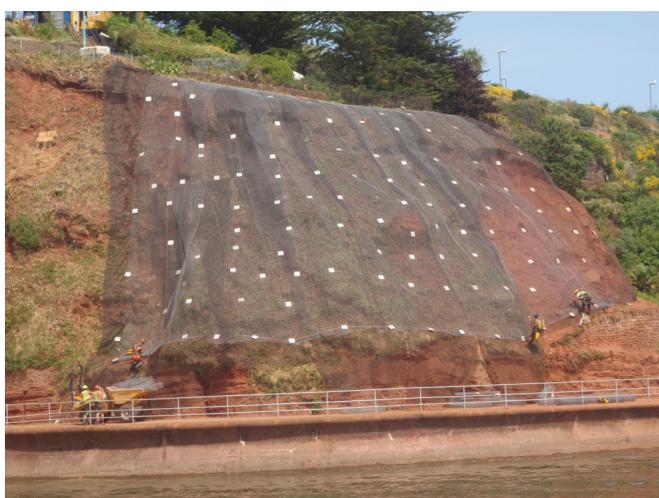
Figure 3. Remedial engineering works at Roundham Head.

In order to remediate the instability, the cliff was covered with a netting revetment to control soil slumping and rockfall hazards (Figure 3). The initial preparation of the cliff included cutting back vegetation, tree removal, clearance of slip debris and loose soil, and scaling with hand tools to remove loose blocks of rock. The revetment comprised a lower layer of small aperture, polyester geogrid (Fortrac 3D 40) to prevent unravelling of soil, and an upper layer of larger aperture rockfall netting (Maccaferri galvanised double twist wire netting with PVC coating) to provide additional strength. The netting was secured to the cliff using a grid of stainless steel dowels of 20 mm diameter and typically up to 2.5 m length that were drilled and grouted into the cliff face. In the west part of the site, wire cable stops were used to provide additional support to a large slender column of breccia rock, partly undermined at its base by the erosion of a weaker sandstone layer. All the products used were selected to withstand exposure to the marine environment. One of the main challenges of the project was determining the likely scope and extent of the remedial works because much of the cliff face was obscured from view by dense vegetation. During vegetation clearance several new areas of potential instability were identified including several large undercut blocks of breccia that could topple out of the face, and tension cracks where the potential for further shallow translational sliding was possible. However, these potential hazards were dealt with by minor adjustments to the planned remedial works, which extended for a total distance of about 120 m and were carried out in two phases in summer and autumn of 2013.

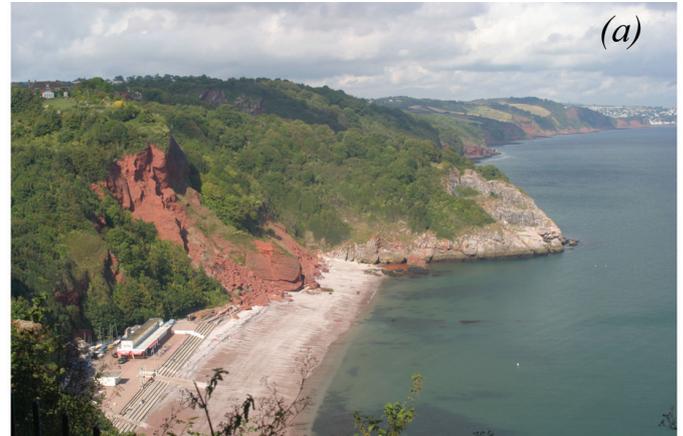
Figure 6. (a) Oddicombe Cliffs in 2005. (b) Tople failure mechanism at Oddicombe Cliffs.

The Oddicombe Breccia Formation has been downfaulted between Devonian limestone and shales at this locality and the deposit has a high content of rounded limestone. Although the strata are well indurated, dip of the bedding determined by original fan deposition and later tilting and faulting, together with interbeds of weaker sandstone, have made the Oddicombe Breccia Formation highly unstable, especially as bedding planes tilting towards the coastline act as conduits for water and promote slipping.

(buildings, garden walls, paths, etc.) and the development of tension cracks in the ground surface at the top of the cliff. Precautionary safety measures taken included closing the north end of Oddicombe Beach (and Little Oddicombe Beach), diverting the coastal footpath further inland and abandoning property at the top of the cliff.

The progressive topple failure affected a 150 m long section of the cliff in February-April, 2013. The first falls occurred at the north end of the cliff resulting in cliff-top regression of about 10 m. Later that month further falls in the same area undermined Ridgemont House. Finally in early April the remainder of the cliff to the south of the house collapsed with the loss of most of the garden. The new cliff top is now up to 50 m further inland. Most of the debris fell northeastwards onto a wooded slope and spilled out over Little Oddicombe Beach; some debris also fell onto the north end of Oddicombe Beach. The remains of Ridgemont House were demolished in 2014 and the affected areas are now permanently closed off. The topple failure mechanism (Figure 6b) is defined by two sets of steeply inclined persistent joint sets and gently dipping bedding planes. One of the joint set dips steeply towards the southwest and results in tall, slender and (in places) slightly overhanging columns in the rock mass. Within the cliff the centre of gravity of these columns acts outside its base and results in an overturning moment, but this is resisted by propping from other columns further forward. However, at the cliff face the front column is un-propped and can therefore rotate forwards and fall out of the cliff. Other factors that reduce stability include weak sandstone layers, water pressure and other hidden flaws (faults, etc.) that might be present in the rock mass.

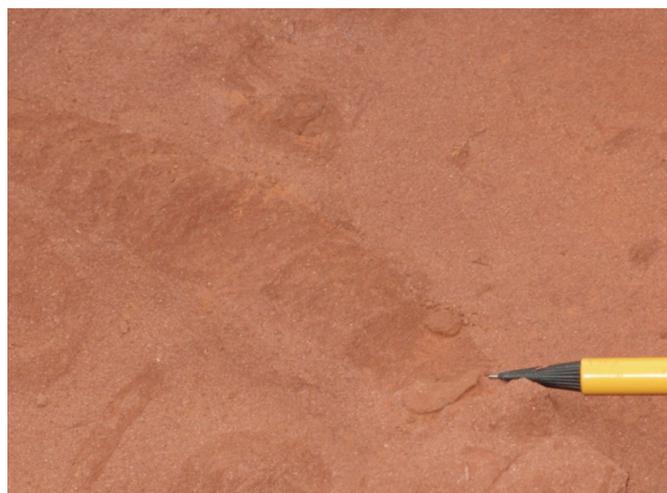
Figure 7. Rare worm burrows in the Watcombe Formation at Pettit Tor.

The Pettitor Member of the Watcombe Formation rests unconformably on the Saltern Cove Formation at this locality. It is dominated by limestone clasts and may reflect a collapsed karst landscape (Leveridge *et al.*, 2003). The Watcombe Formation at Pettit Tor is dominated by finer material with minor clast lenses and rare worm borrows (Figure 7). A marked angular unconformity between the Watcombe Formation and the Oddicombe Breccia Formation most likely represents syn-depositional fault sedimentation (McVicar Wright, 2014). The Oddicombe Breccia at this locality is relatively more stable due to more favourable bedding inclination.
