BURSTING AND HEAVING LEDGES ON MONMOUTH BEACH, LYME REGIS

R.P.H. EDMONDS

Edmonds, R.P.H. 2016. Bursting and heaving ledges on Monmouth Beach, Lyme Regis. *Geoscience in South-West England*, **14**, 12–16.

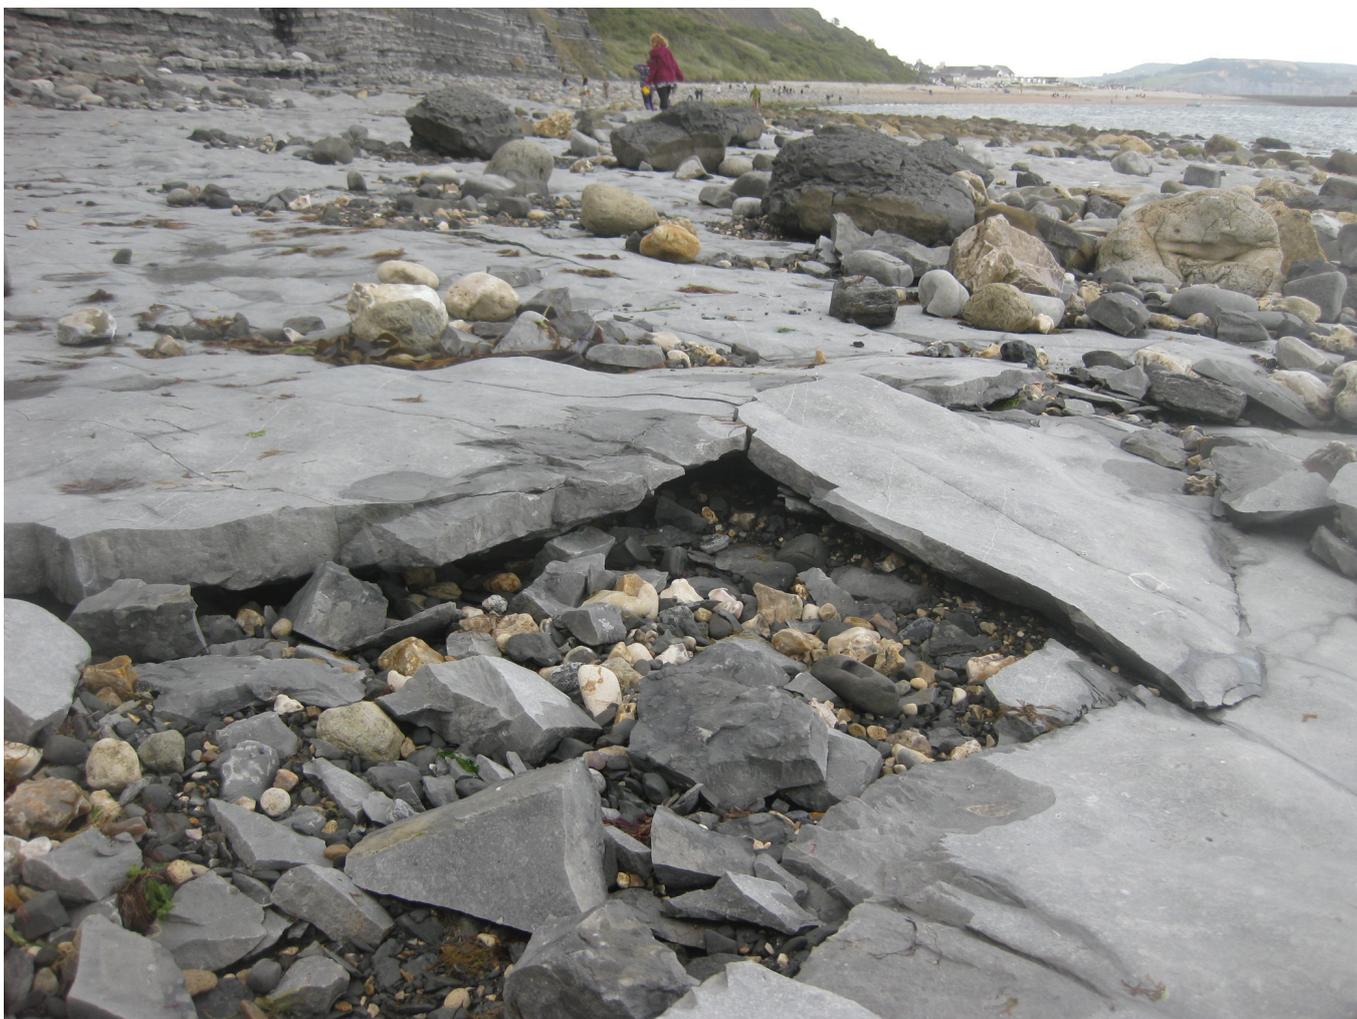
Figure 1. The spectacular heave in Bed 19 (Lang, 1924) during July and August 2011.

Sometime between the 19th and the 28th July 2011 an area in the middle of the most easterly of the extensive middle shore wave cut platforms (Grid Reference: SY33021 91243), the Specketty (Bed 19 of Lang, 1924), burst open over an 8 m by 3 m area. The jointed edges showed compression, with uplifted blocks and spalling or flaking along the surfaces adjacent to the jointing which extended into the unbroken areas of the pavement (Figure 1). The failure was progressive, continuing until the 11th August. An earlier but smaller event was observed in August 2010 and previous photographic monitoring showed that another had occurred sometime before the summer of 2008.

In August 2011 the failure in the Specketty (Bed 19) was captured by shooting a photographic mosaic of images and stitching them together to create a very high resolution record of the feature before it was modified by the sea. The bed had thinned very considerably in places, due to attrition of the surface and the failure appeared to be controlled by a bioturbated parting within the limestone. The Specketty is characterised by this bioturbated level, but here the limestone, which is up to 40 cm thick, was split and this level took the form of a clay parting. In places where the failure occurred, the top surface was between about 12 cm and just 3 cm thick. A simple model is proposed for the failure: attrition thins the upper limestone layer, the jointing opens up and then it fails. The cause is more problematic and will be discussed later. This event happened during a very hot spell of weather, as recorded at Bridport (www.bridportweather.co.uk/weather/index.htm), during neap tides and calm seas as recorded by the West Bay wave rider buoy.

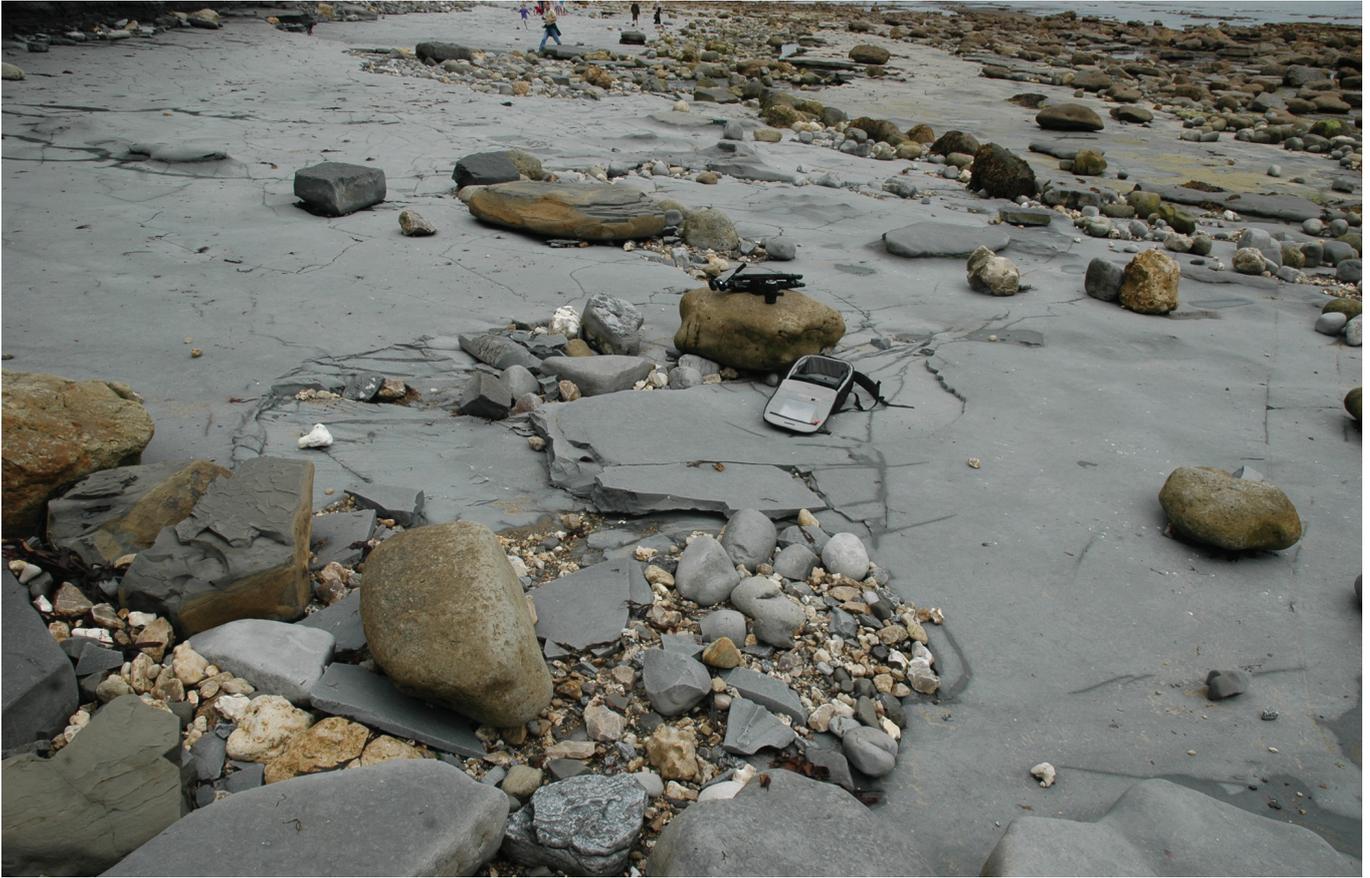
Figure 2. Compressional and flaking features in Bed 31 towards Seven Rock Point, August 2011.

A separate, compressional, failure feature was also observed in August 2011 in the Third Quick (Bed 31) towards Seven Rock Point (SY32889 91107). Here the limestone appeared to have sheared through the middle of the bed, and large flat flakes had, or were in the process of spalling off. It took place at the end of a sinuous joint feature extending eastwards towards the edge of the limestone ledge and appeared to be a westerly

extension of it (Figure 2). Three similar, but older, features were then identified in the Bed 35, the Second Quick, nearby (GR SY32906 91112) and south and east from there where they were associated with east–west trending cracks in the ledge. These cracks do not extend into the beds below, raising the question of the origin of the jointing. Gallois (2012) described the tectonic setting for the area, and identified both N–S and E–W trending faults, which presumably control many of the jointing features in the platforms. In the same bed in this area, pull apart jointing was observed by Ian West during a trip to see these features. Here it can be seen that large sections of the northern edge of the ledge have rotated slightly, in a horizontal sense, thereby creating corresponding compressional failures (Figure 3). Similar, but larger scale features can also be seen in the Mongrel (Bed 23, Lang, 1924) at SY32971 91170. Here a long, linear crack runs east–west through the ledge, but it widens to the east. The whole ledge, therefore, has rotated and in doing so, it has compressed the northern edge, an edge that contains four gullies. The widest are on the eastern side, while the narrowest are to the west. The penultimate western one contains a block that has been displaced vertically while the most western one has the freshest cracks and jointing.

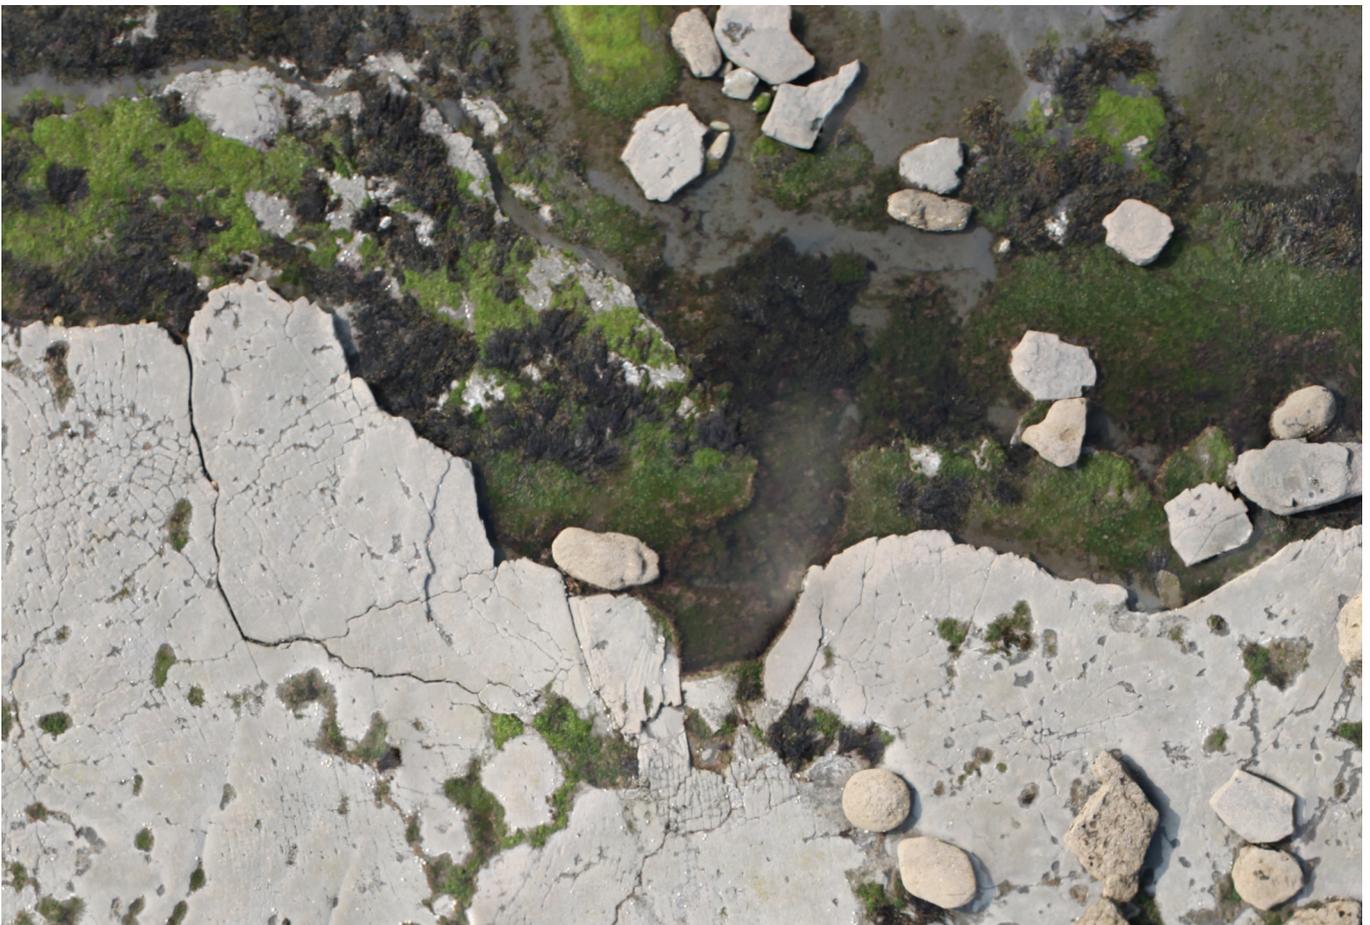
Figure 3. Horizontal rotation of a block of limestone (left) and subsequent compression (middle), northern edge of Bed 35, Seven Rock Point. The image covers approximately 8 m on the ground.

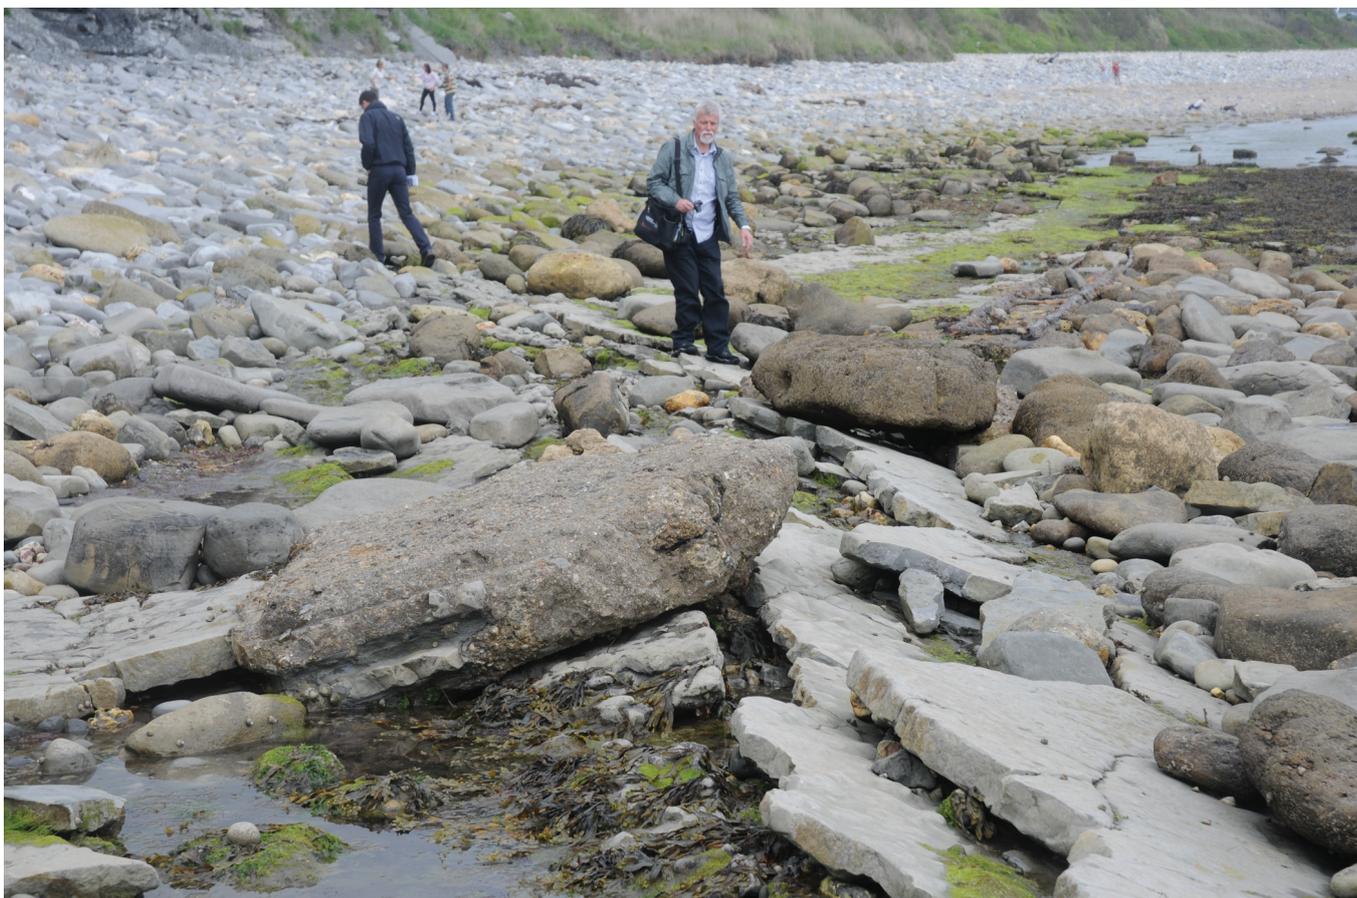
Figure 4. The remains of the old tramline with concrete blocks tilted in opposite directions over a fault. The rail tracks can be seen in the distance.

The failure in the Specketty and Third Quick are ‘contained’ in that the beds are continuous into the cliff face, while those in the Second Quick and Mongrel are ‘unconstrained’ in that the beds have been eroded into ledges that are isolated from the cliff. A final, startling and very obvious observation was made by Alan Powderham during another site visit. The surviving section of the old quarrymen’s tram line probably constructed in 1908 at SY3306691279 crosses a tectonic fault with mineralised slickensides showing listric movement. The

tramway was set into blocks of concrete on Bed 9, yet the two blocks straddling the fault have been tilted in opposite directions either side of the fault (Figure 4). Fresh flaking was evident along some of the jointing in the bed: this fault, or the beds around it at least, have been moving! The Channel Coast Observatory undertook a ground based LiDAR survey of this area which determined up to 45 cm of uplift in the concrete blocks.
