A LEGACY SLOPE FAILURE IN PENLEE QUARRY - A WARNING TO OTHERS

McAllister, R., Walton, G., Coggan, J. and Wetherelt, A. 2013. A legacy slope failure in Penlee Quarry - a warning to others. *Geoscience in South-West England*, **13**, 183-190.

Penlee Quarry has a 90 m high slope which is 50-60 years old and is showing increasing signs of instability with two significant collapses in 2010 and 2011. The latter collapse gave rise to a possible flow slide at the toe and a significant air blast. This paper presents details of the underlying joints controlling ground movements, the investigation of these joints and proposals for remedial works. There are implications for other similar slopes elsewhere in England.

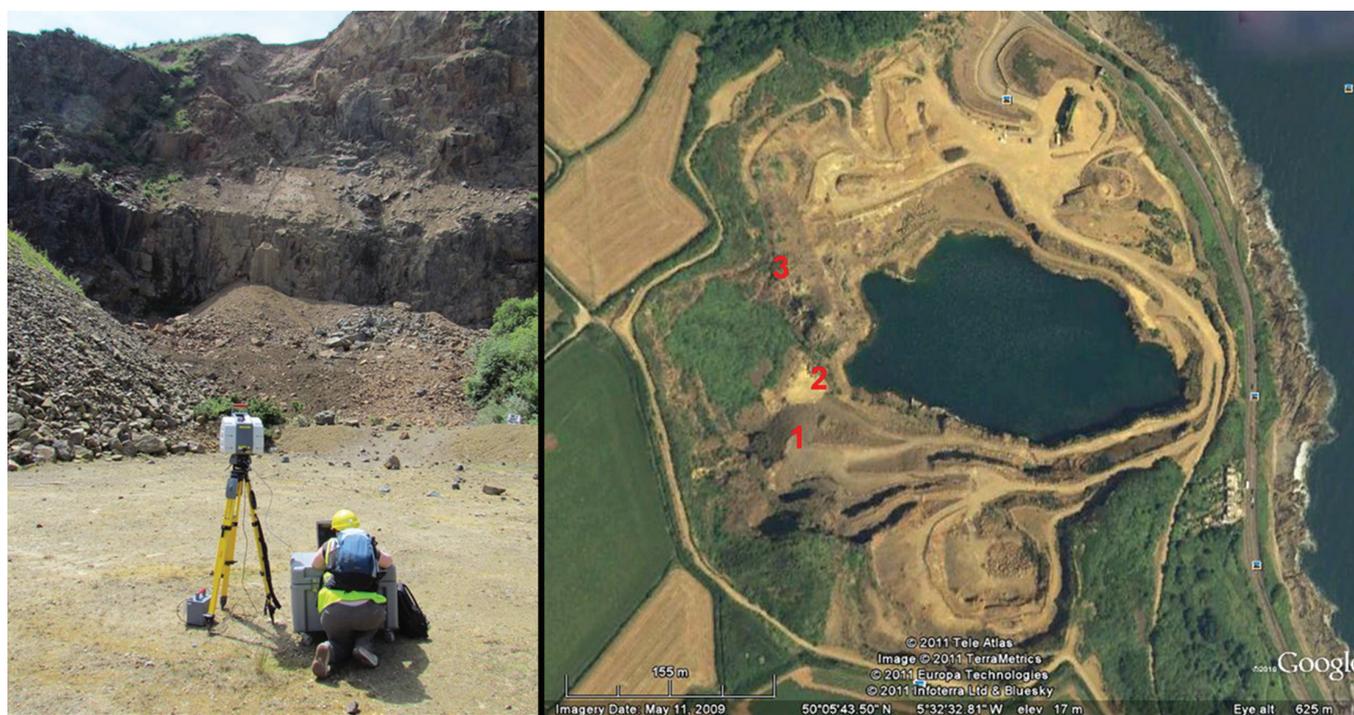
Figure 8. The set up for the laser scanning survey (left) and the Google image of the quarry showing the 3 survey set up positions (right). The illustrated set up is in position 2; the Google image of the quarry dates from before the collapse.
